Title 5 Official Inspection Form

44 Bay Road

19 February 2026

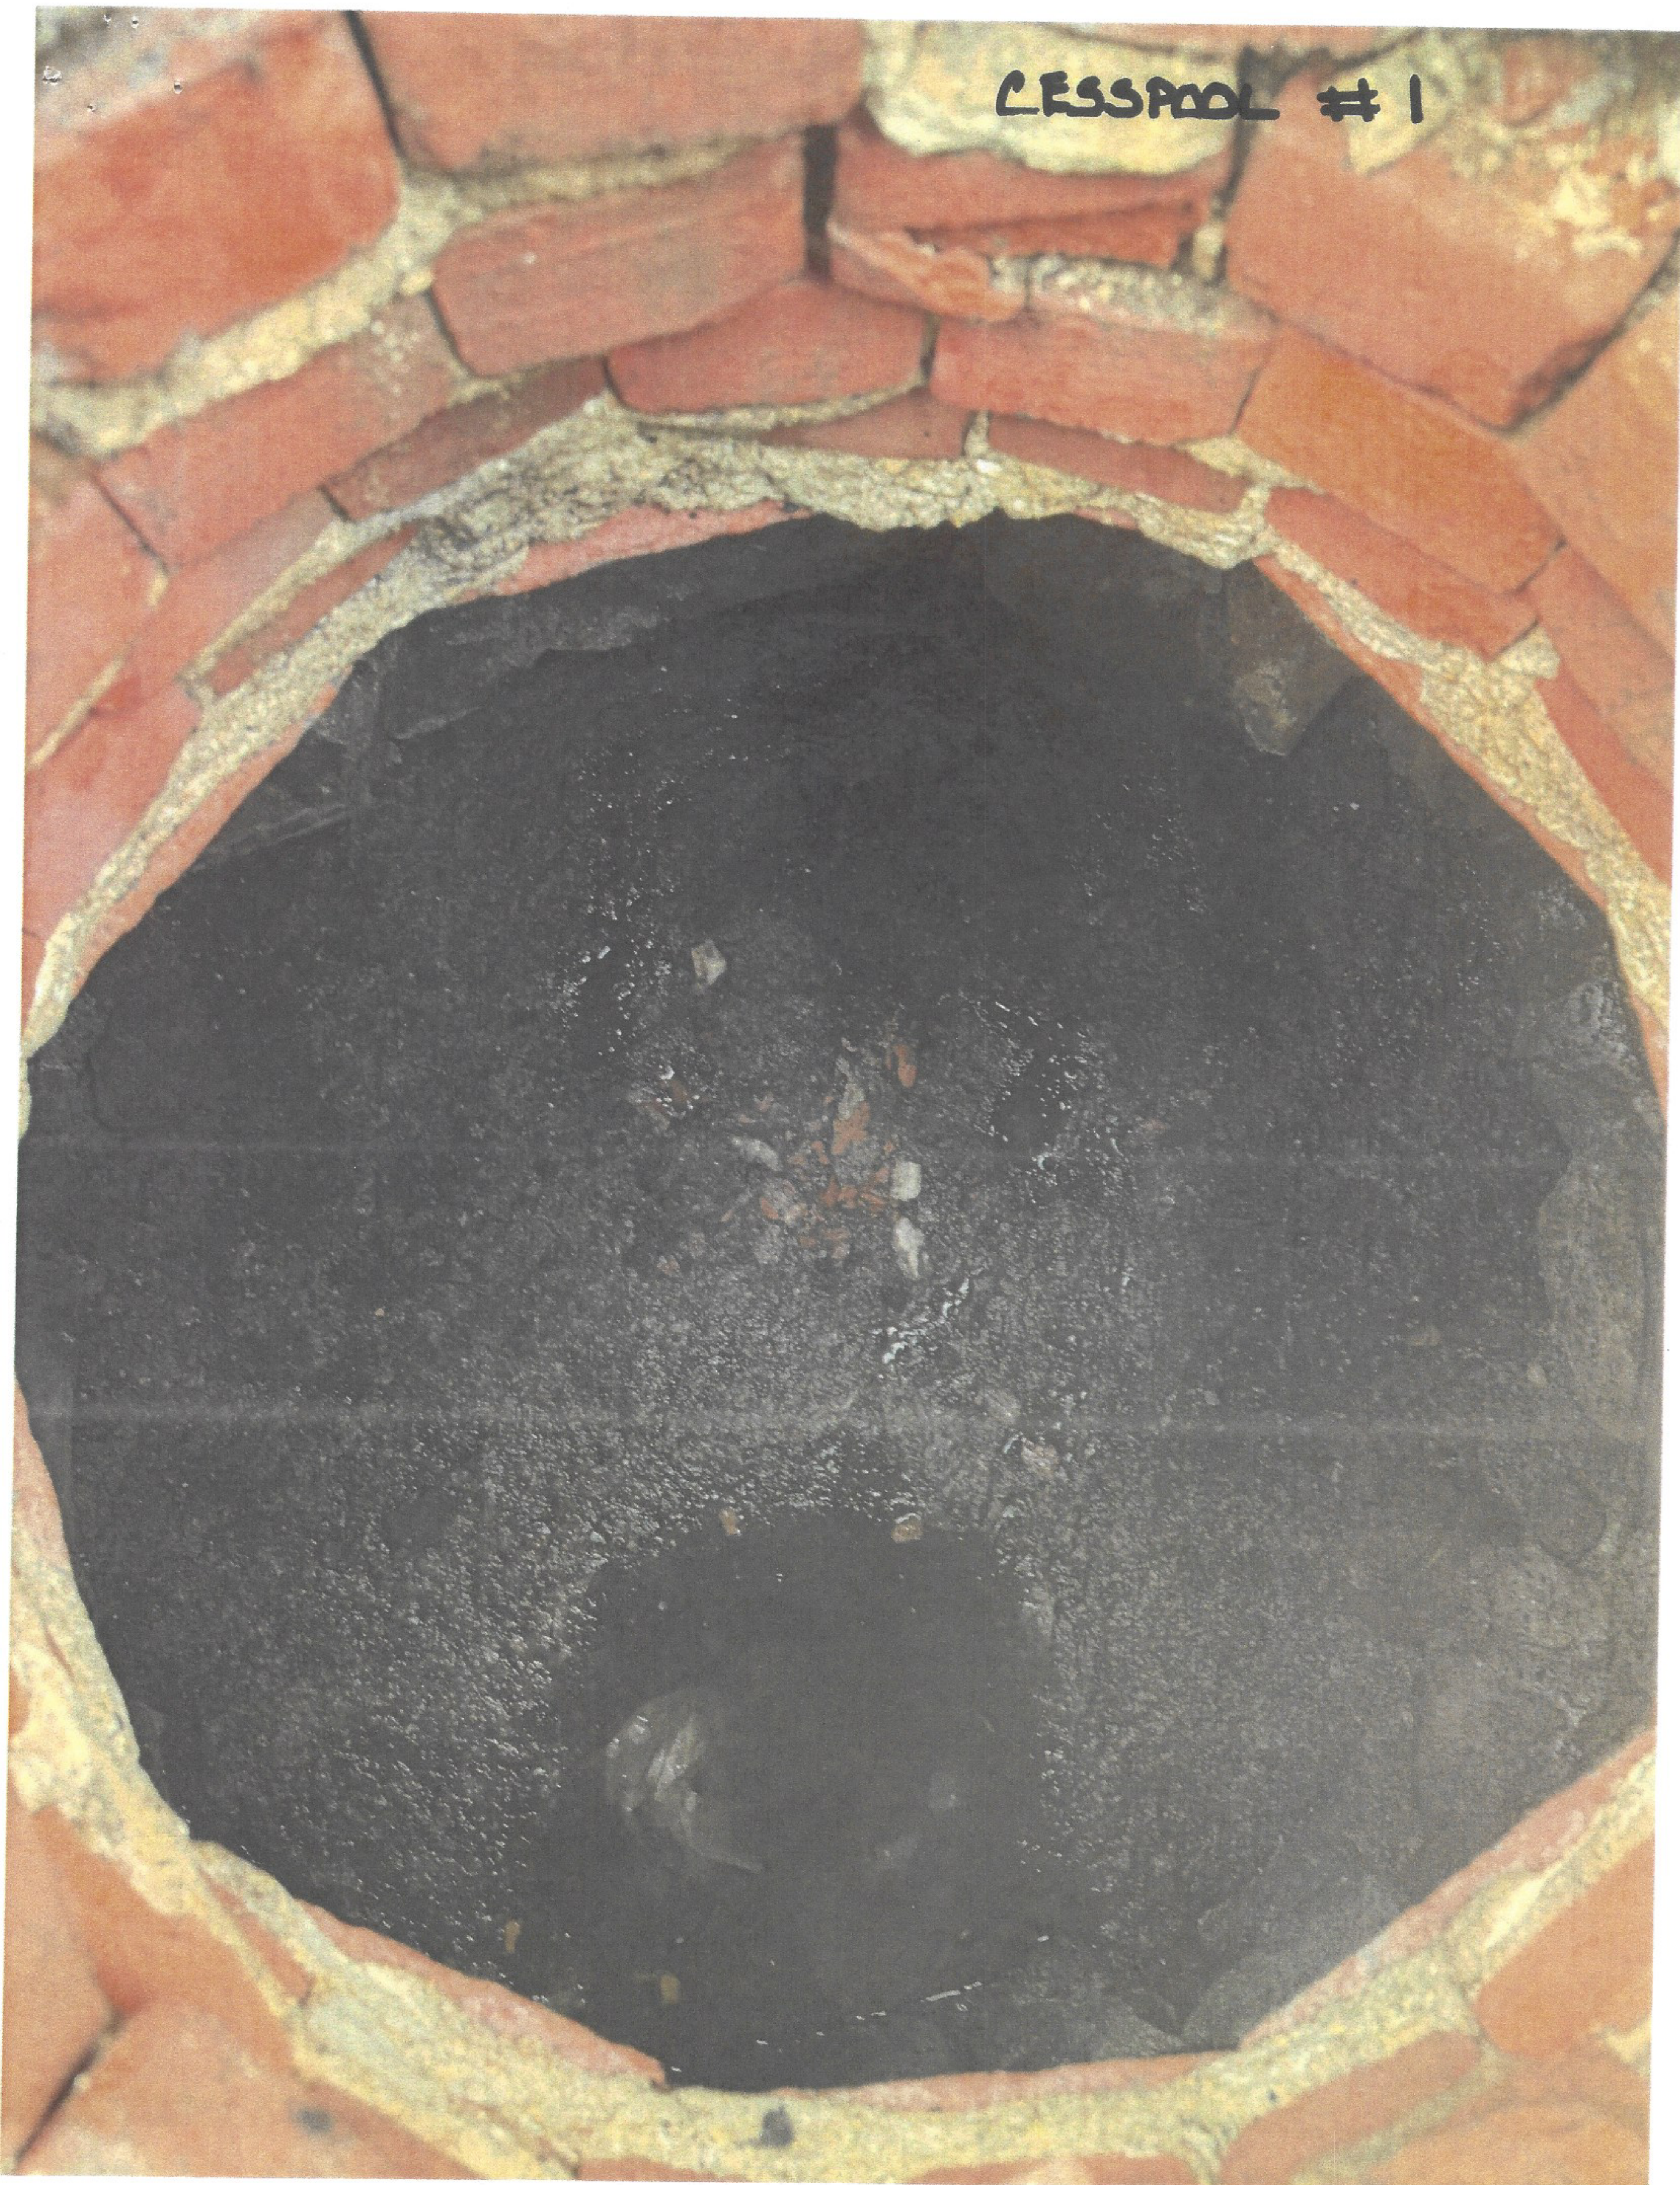
CESPOOL #1

Both cesspool had 0" of standing liquid and no evidence of staining beyond the first few inches of each cesspool. No solids or scum were evident during the inspection.

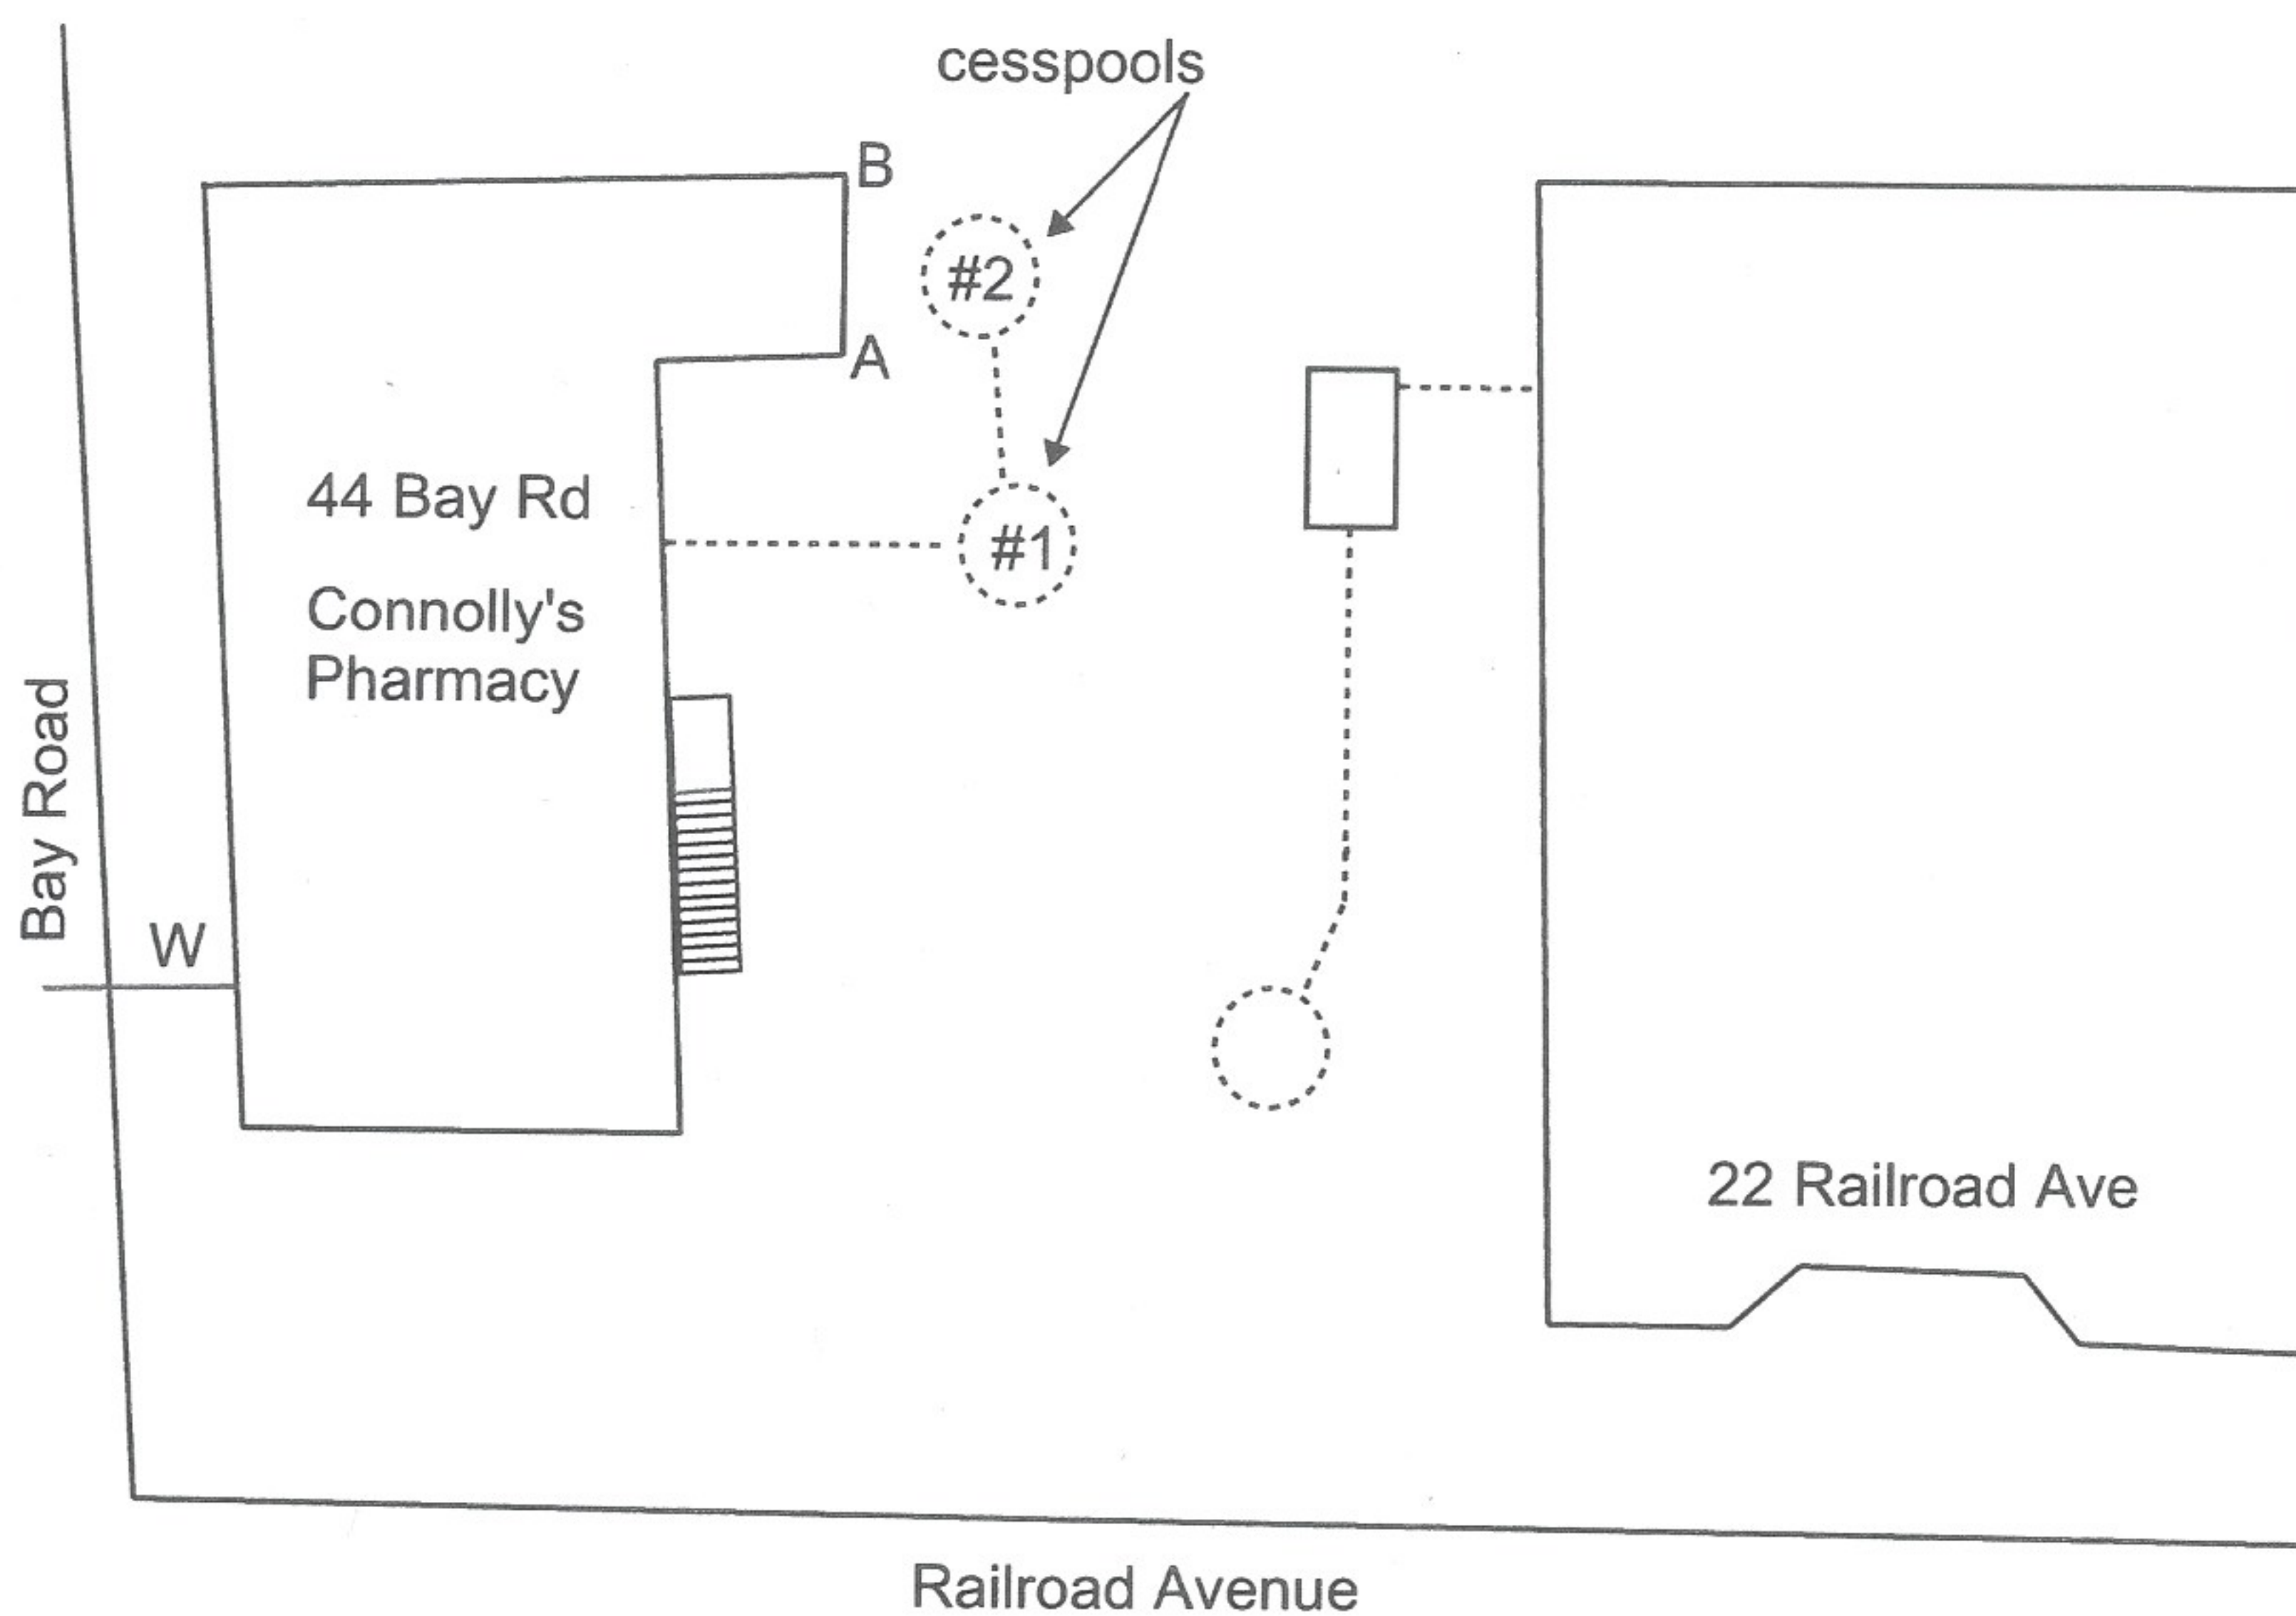
Title 5 Inspection
44 Bay Road, Hamilton, MA
February 2026
plan NTS

#1	#2
A	10.2'	8.4'
B	20.1'	4.2'
