**Phase I Environmental Site Assessment**

**Land for Proposed 11th and McDowell Apartments  
Former Medical Buildings and Portions of Residential Lots  
NWC, 11th Street and McDowell Road  
Phoenix, Arizona 85006**

**May 25, 2023**

**Project 28378**

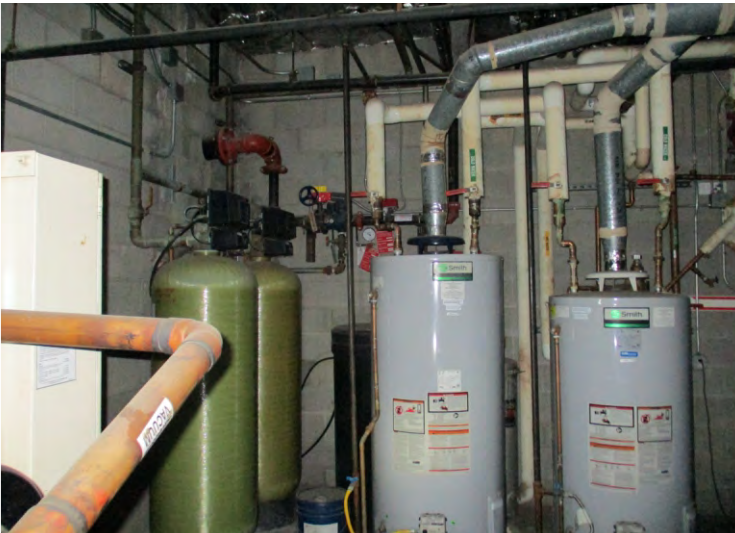
Photo 17 - View of water heaters and water softeners in the surgical center building mechanical room.

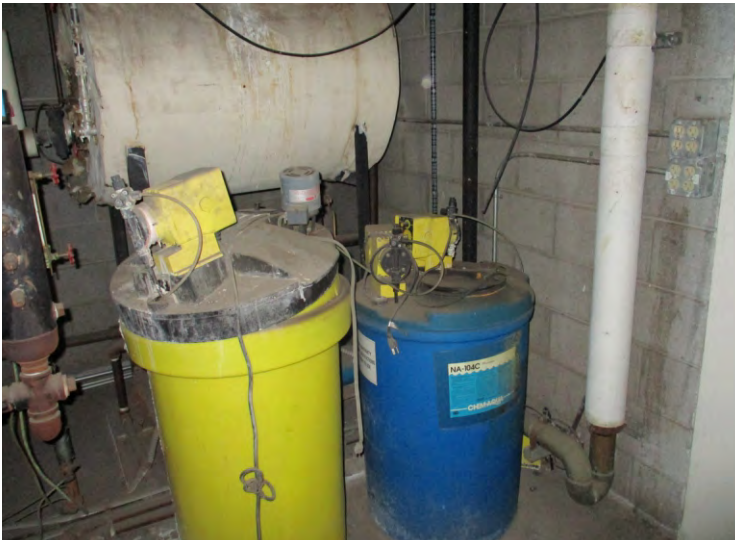
The surgical center building is heated and cooled with roof-mounted electric package units. There are remnants of a former heating and cooling system in the basement including natural gas-fueled boilers. Two plastic drums for nonhazardous water conditioner and two cylinders for water softener resin were seen in connection with the boilers. The former basement oxygen storage areas described in the 2019 ESA were seen to be empty.

Photo 18 - View of water conditioner drums in the surgical center building mechanical room.

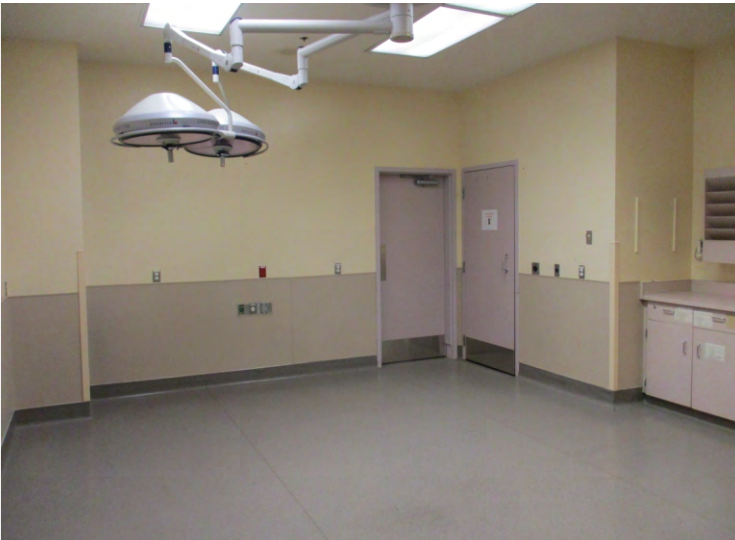
The surgical center includes former operating rooms, patient rooms, nurse stations, offices, a kitchenette and a locker room. Most furnishings, fixtures and supplies have been removed but some equipment, including lamps, tables and a gurney remain. Chemical storage is limited to the water conditioner drums and a few pails of paint.

Photo 19 - View of an operating room in the surgical center building.

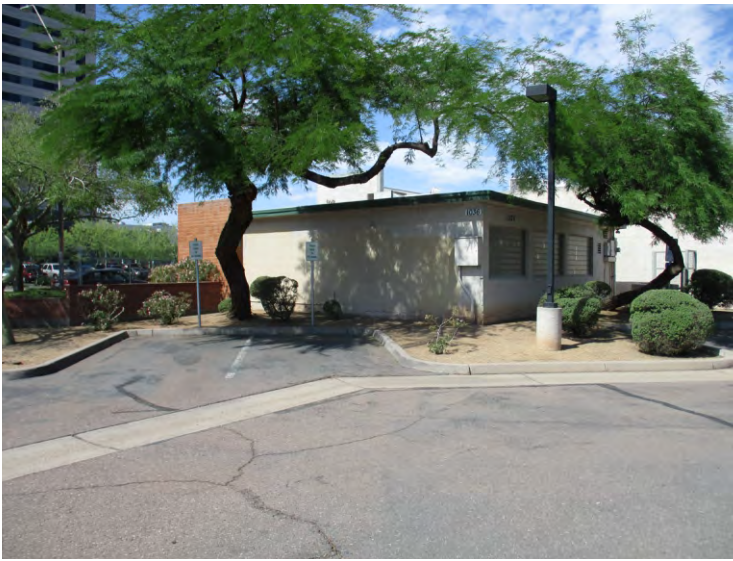
The southeast building at 1036 E. McDowell Road is a single-story building partially of masonry construction with Transite panels in metal frames forming its south wall. The roof is polyurethane foam with white elastomeric coating over wooden structure. The building is heated and cooled with roof-mounted electrical equipment. The building is empty except for a kitchenette. No chemical storage was noted.

Photo 20 - View of the 1036 building, looking southwest.

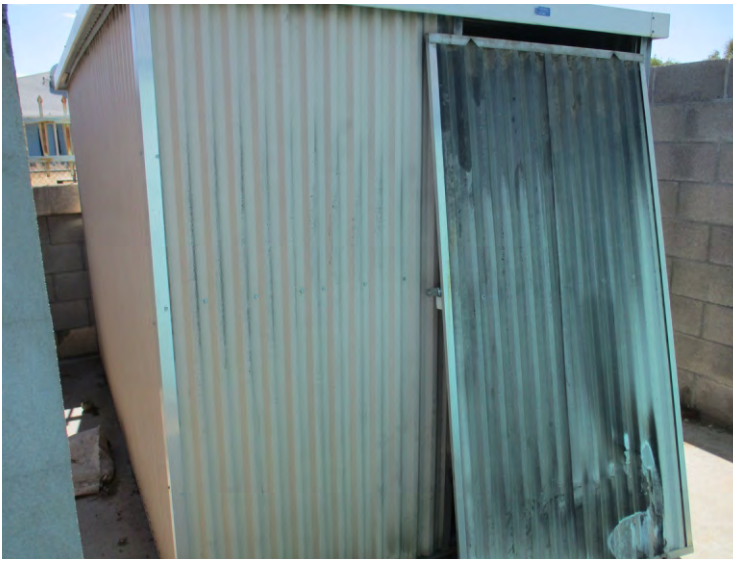
Photo 32 - View of the former medical waste shed near the northeast corner of the surgical center building.

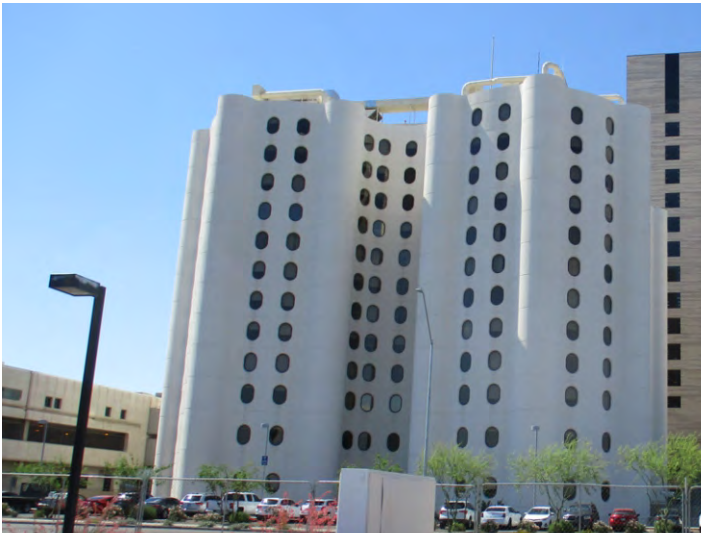
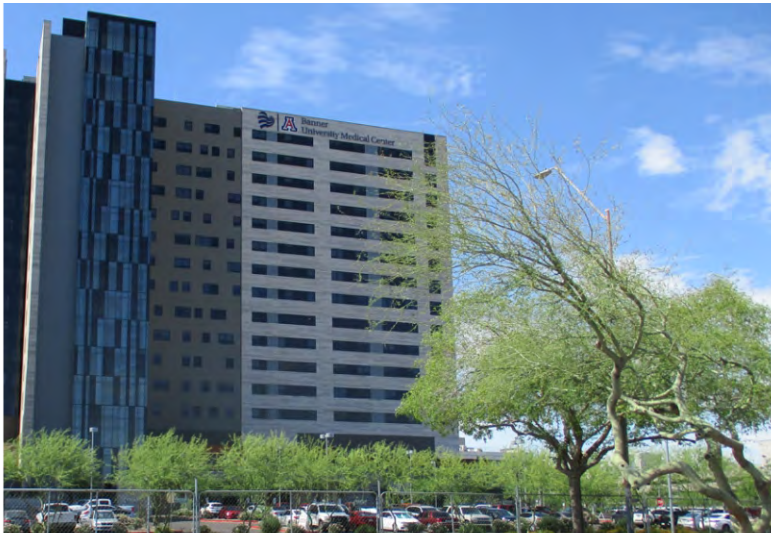
developing solutions and other medical hazardous wastes. Banner University Medical Center appears on the RCRA Compliance Log for violations that occurred in 2001 and 2006. Each of these listings includes a “return to compliance” date, which indicates the issue that led to the violation was resolved to the satisfaction of EPA. Based on this information, this adjoining RCRA generator is unlikely to have adversely affected the property.

Photos 40, 41 - View of the south adjoining Banner University Medical Center, looking southeast and south across McDowell Road from the subject property.
