Regulated Building Materials Assessment Report

Kent Central Motel
1233 Central Ave North
Kent, Washington

December 3, 2020

Terracon Project No.81207486

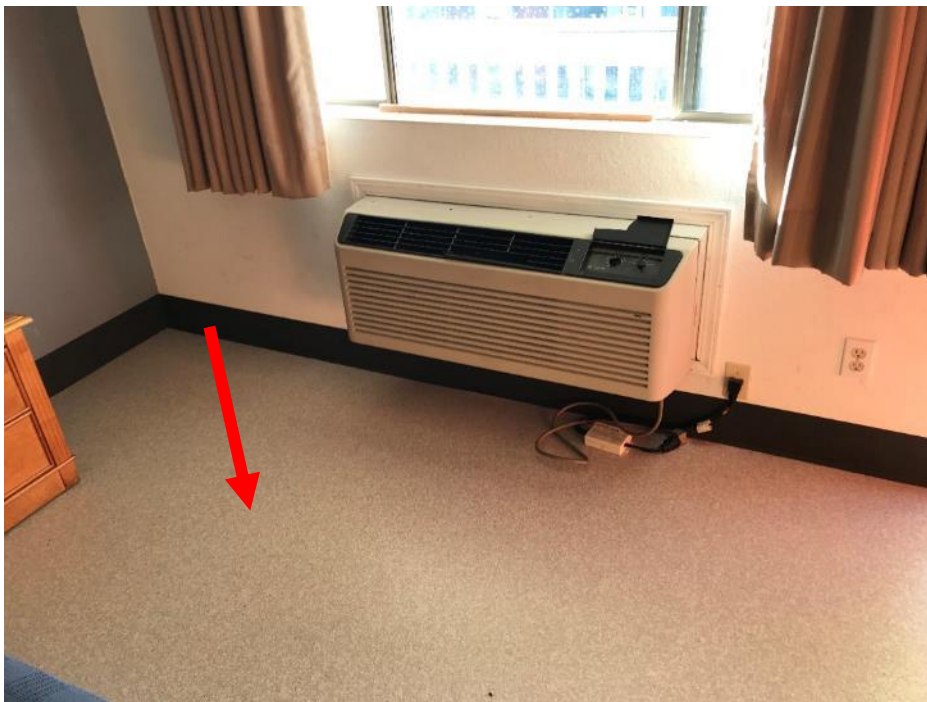
HSA ID, Material Description, and AHERA Classification	Material Location	HSA Results
1: Grey pebble pattern vinyl floor sheeting, yellow mastic, and grey leveling compound (M)	Flooring in guest rooms in places throughout project area	Vinyl: ND Mastic: ND Leveling compound: ND

HA No. 1. Grey pebble pattern vinyl floor sheeting, yellow mastic, and grey leveling compound (M)

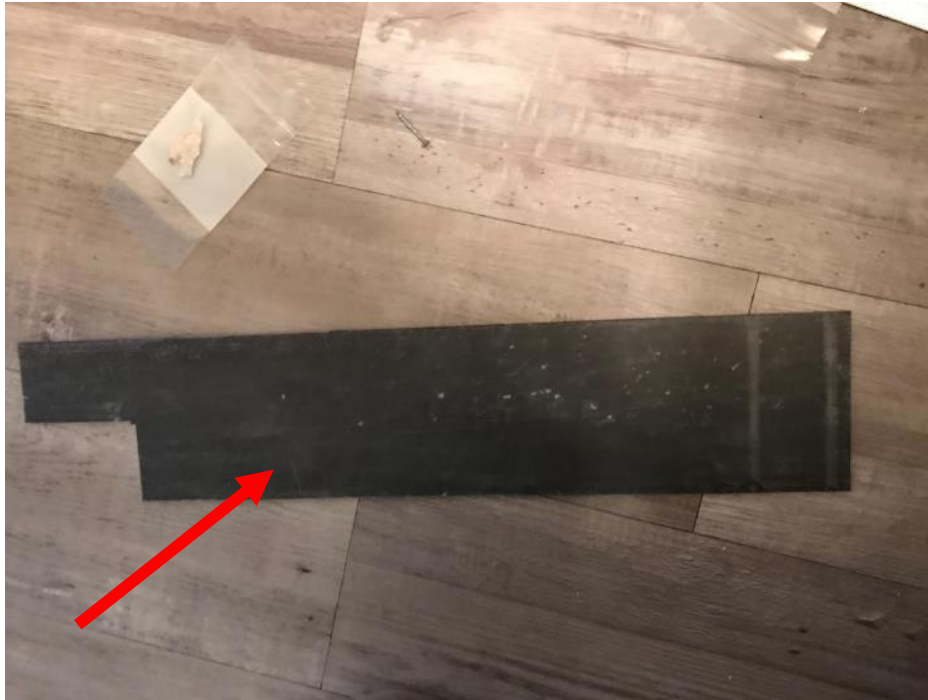
2: Grey wood pattern tongue and groove vinyl floor tiles and grey leveling compound (M)	Flooring in guest rooms in places throughout project area	Vinyl: ND Leveling compound: ND

HA No. 2. Grey wood pattern tongue and groove vinyl floor tiles and grey leveling compound (M)

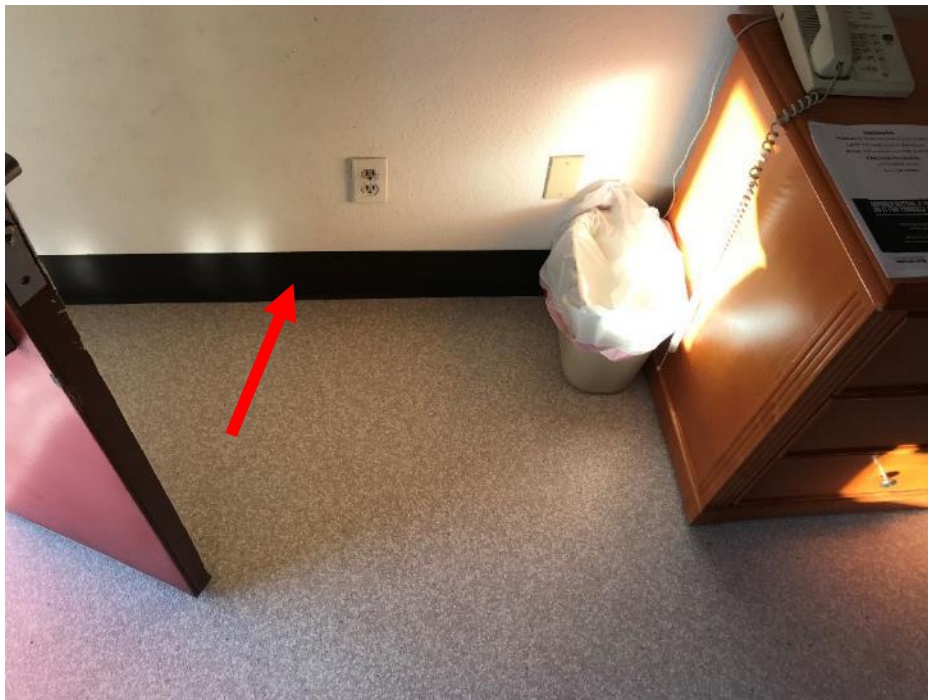
3: 6" Brown rubber cove base, yellow mastic, and white joint compound (M)	At base of wall in guest rooms throughout project area	Cove base: ND Mastic: ND Joint compound: ND

HA No. 3. 6" Brown rubber cove base, yellow mastic, and white joint compound (M)

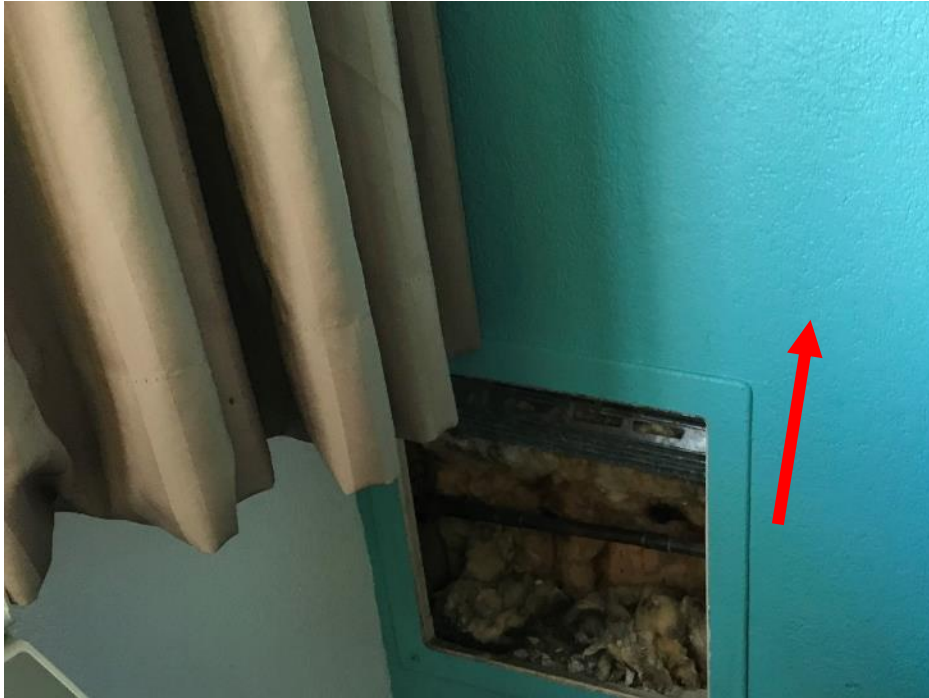
4: White texture (S), beige wallpaper, beige mastic, white joint compound, white paper, white joint compound, white gypsum wallboard (M)	Walls and ceilings throughout project area	Texture: ND Wallpaper: ND Mastic: ND Joint compound: ND to <1% chrysotile Paper: ND Joint compound: ND

HA No. 4. White texture (S), beige wallpaper, beige mastic, white joint compound, white paper, white joint compound, white gypsum wallboard (M)

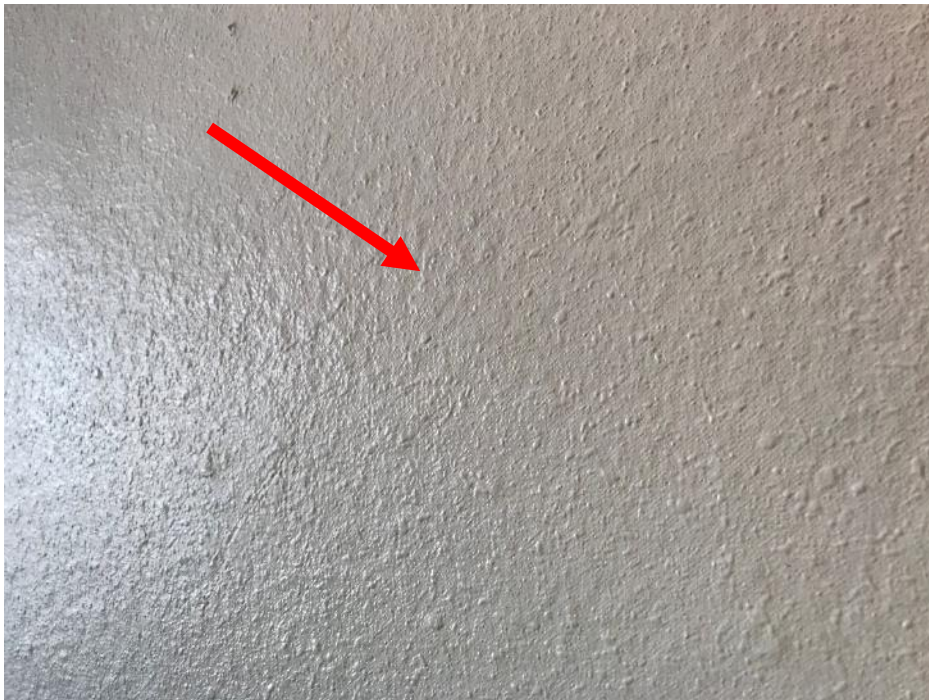
HSA ID, Material Description, and AHERA Classification	Material Location	HSA Results
5: White texture (S), beige wallpaper, beige mastic, white paper, and joint compound (M)	Wall texture throughout building C and predominate wall texture building A and B	Texture: ND Wallpaper: ND Mastic: ND Paper: ND Joint compound: ND to <1% chrysotile

HA No. 5. White texture (S), beige wallpaper, beige mastic, white paper, and joint compound (M)

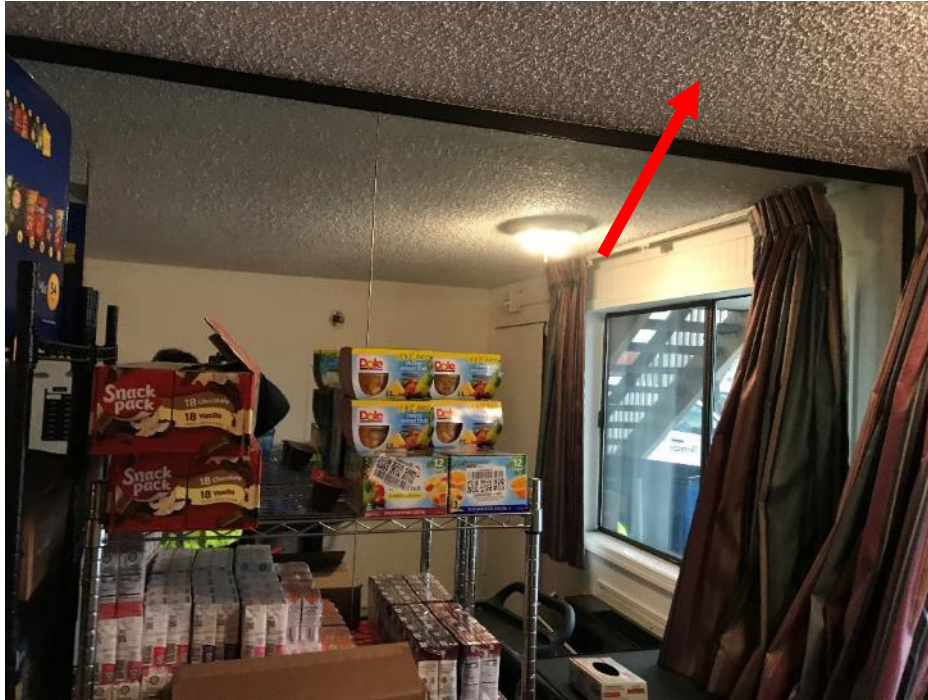
6: White popcorn texture (S)	Predominant ceiling texture in guest rooms and in place throughout buildings	Texture: 3% to 5% Chrysotile
7: 4" brown rubber cove base and beige mastic (M)	At base of walls in maintenance closets throughout project area	Cove base: ND Mastic: ND

HA No. 6. White popcorn texture (S)

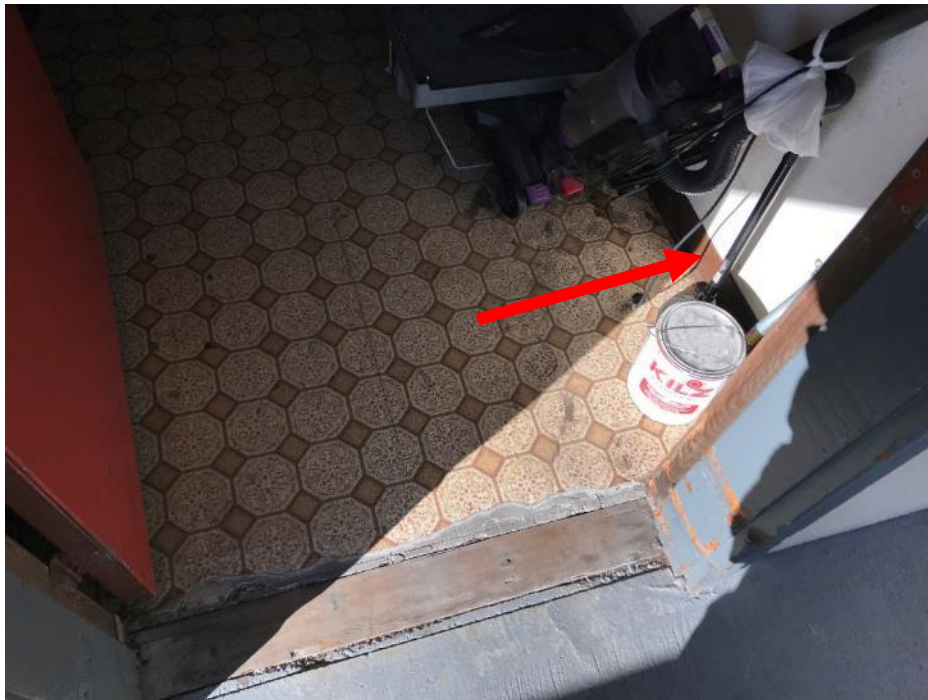
HA No. 7. 4" brown rubber cove base and beige mastic (M)

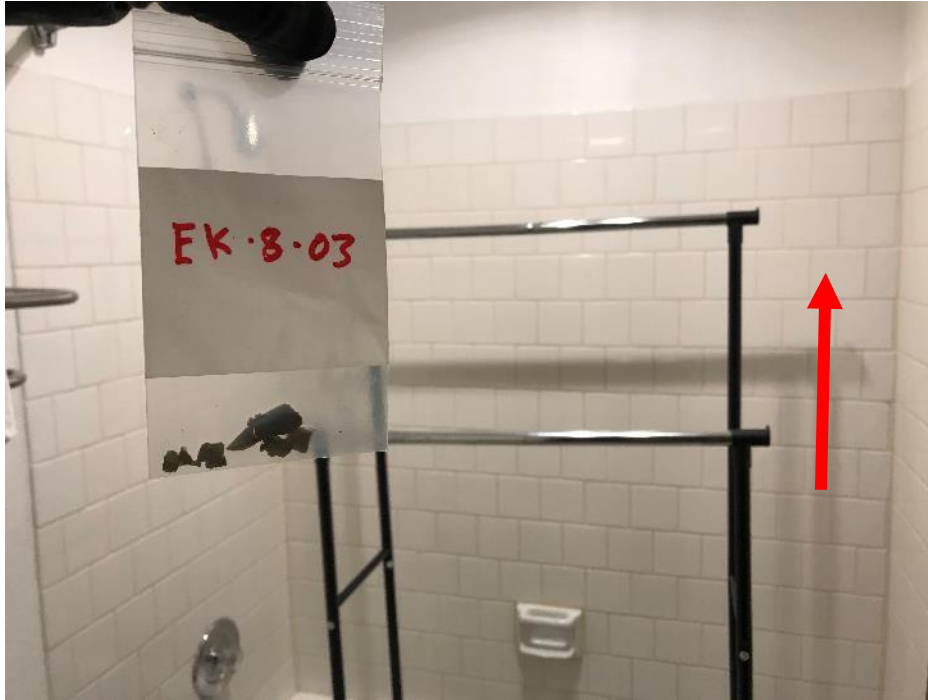
8: 4"x 4" white ceramic tile, white grout, yellow mastic, and white joint compound (M)	Predominate tiles on shower walls and window sills in places throughout project area	Tile: ND Grout: ND Mastic: ND Joint compound: ND to <1% chrysotile

HA No. 8. 4"x 4" white ceramic tile, white grout, yellow mastic, and white joint compound (M)

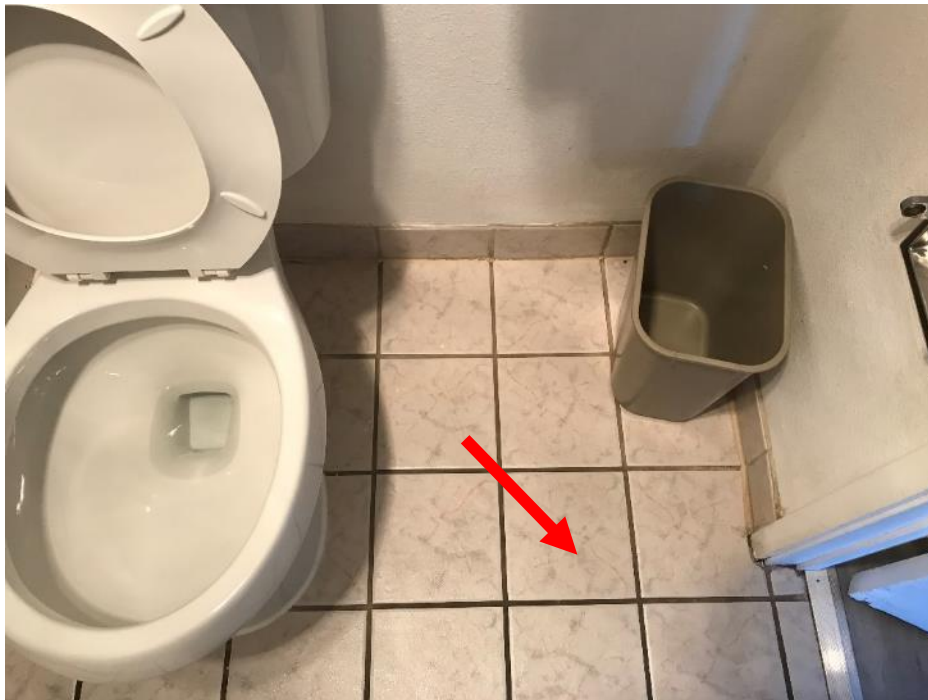
HA No. 9. 8"x 8" white ceramic tile, red grout, and grey mortar bed (M)

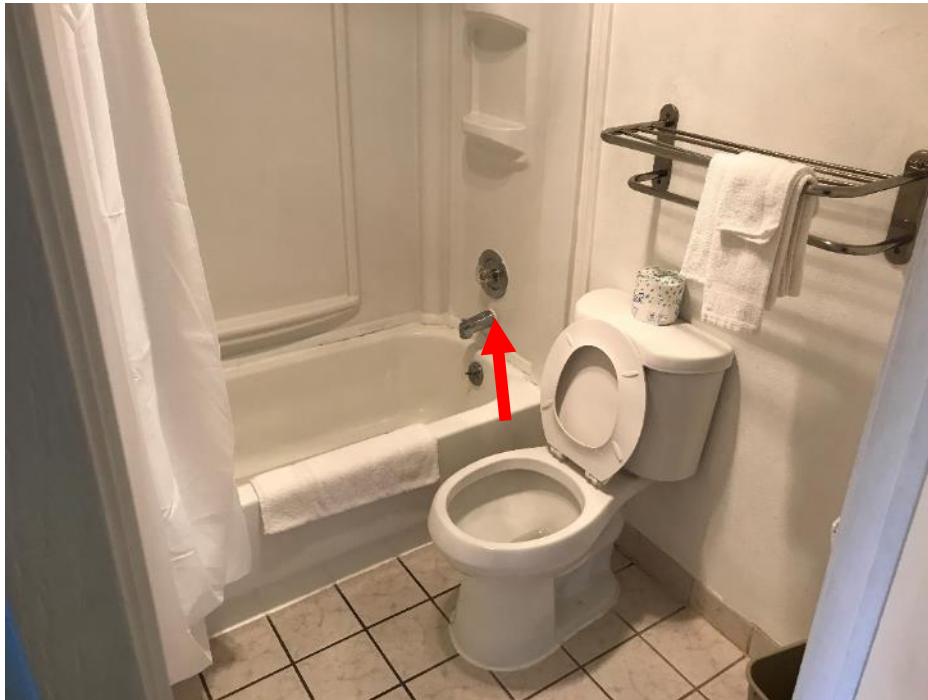
HA No. 10. White sealant, white mastic, and white joint compound (M)

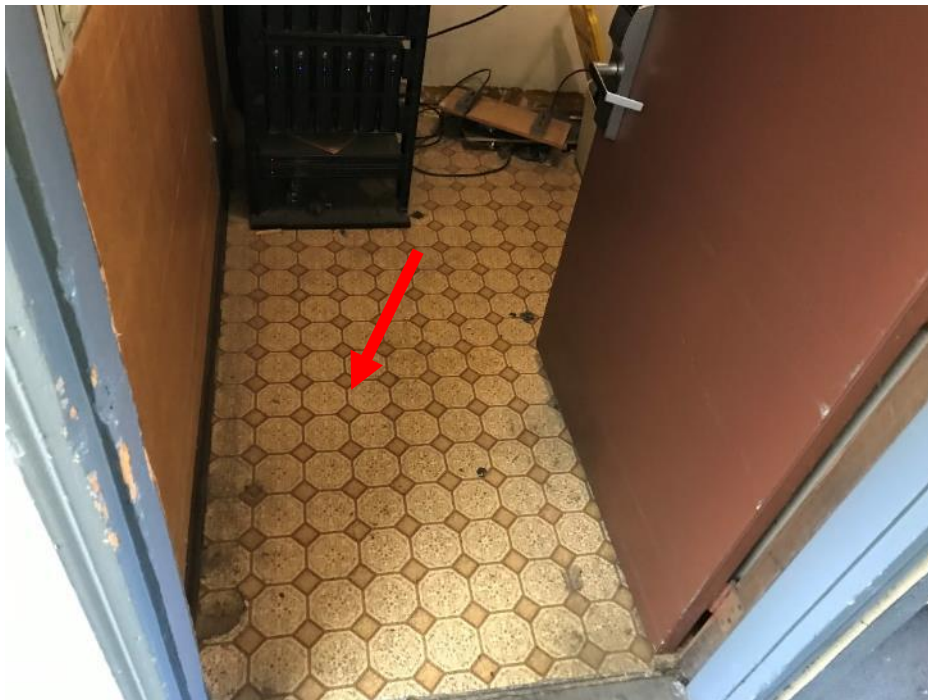
11: Tan and brown diamond pattern vinyl floor sheeting tiles with tan mastic (M)	Flooring in places in laundry, water heater, storage, electrical, and maintenance rooms	Vinyl floor sheeting tiles: 30% chrysotile

HA No. 11. Tan and brown diamond pattern vinyl floor sheeting with tan mastic (M)

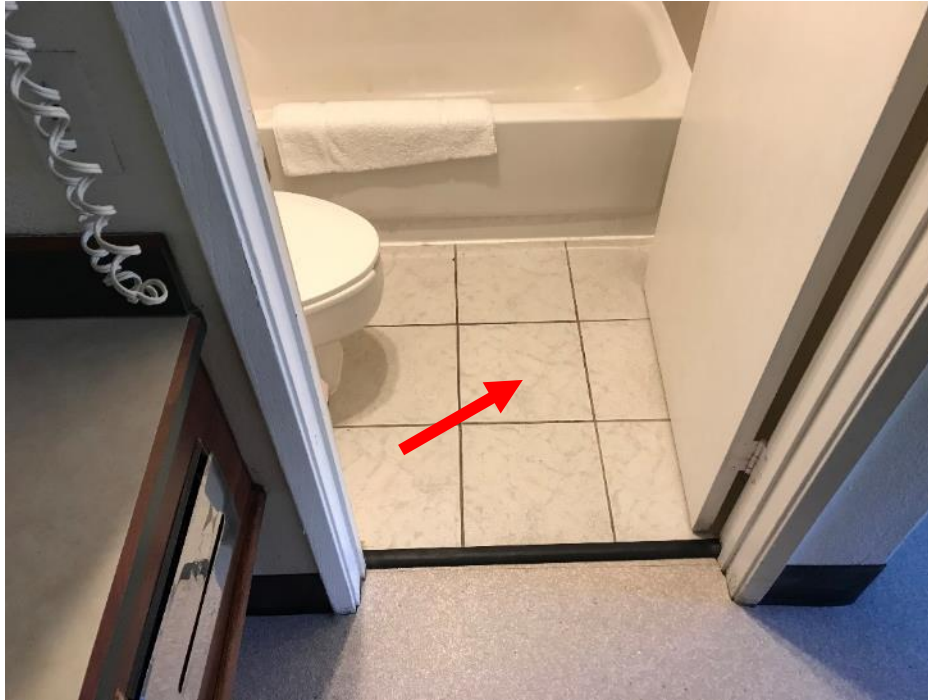
HA No. 12. 12"x 12" white ceramic floor tile and grey grout (M)

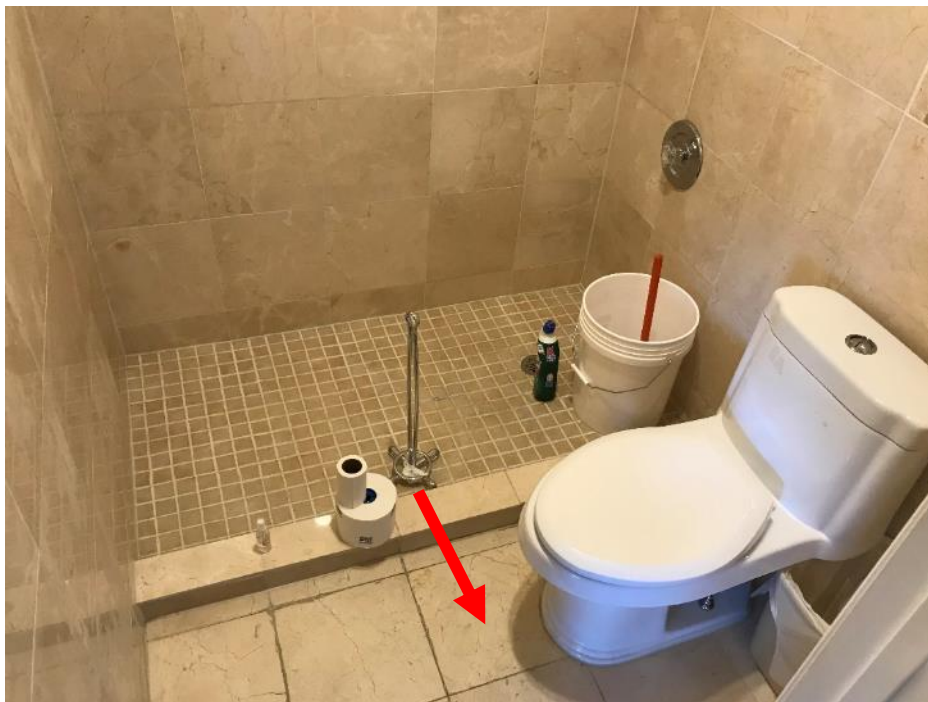
HA No. 13. 12"x 12" brown ceramic floor tile with brown grout (M)

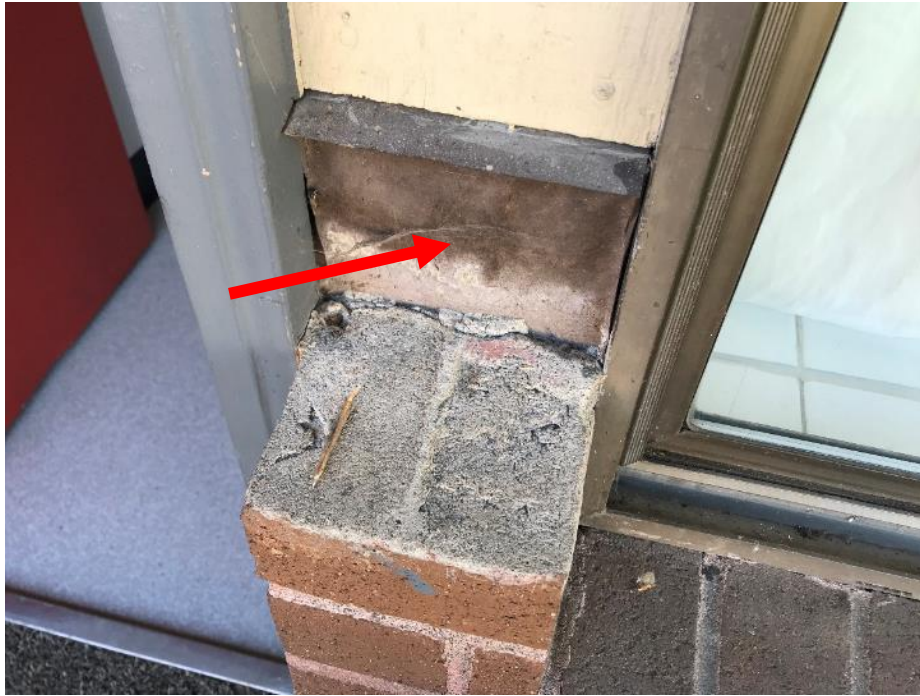
HA No. 14. Brown asphaltic vapor barrier (M)

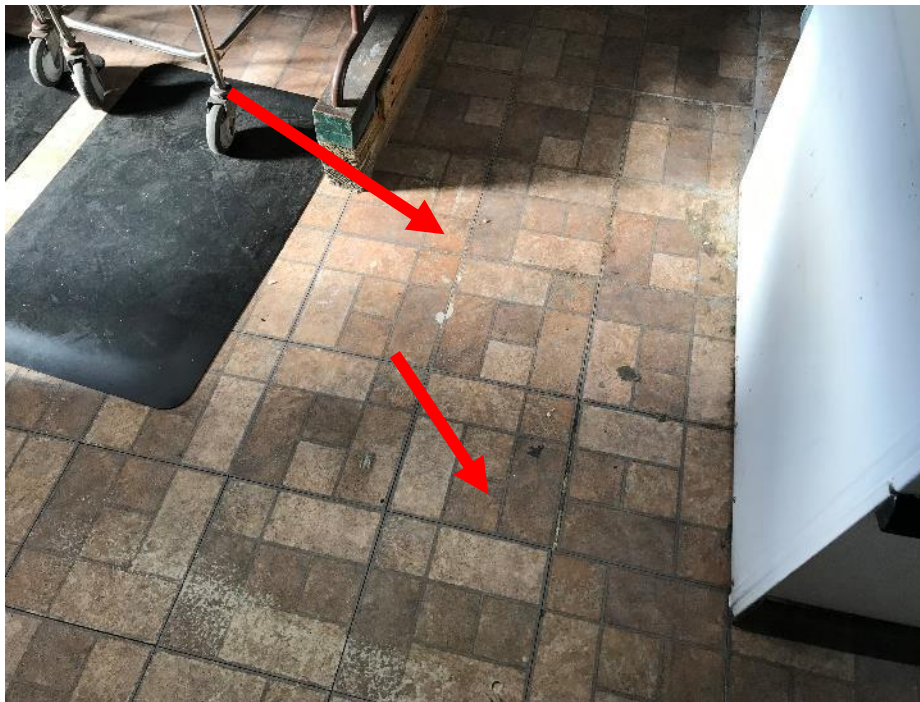
HSA ID, Material Description, and AHERA Classification	Material Location	HSA Results
16: 12"x 12" red brick pattern vinyl floor tile, clear mastic with debris, black coating, Tan mastic, and brown vinyl floor sheeting(M)	Flooring throughout building B laundry room	Vinyl tile: ND Clear mastic: ND Black coating: ND Tan mastic: ND Vinyl floor sheeting backing: 15% Chrysotile

HA No. 16. 12"x 12" red brick pattern vinyl floor tile, clear mastic with debris, black coating, Tan mastic, and brown vinyl floor sheeting(M)

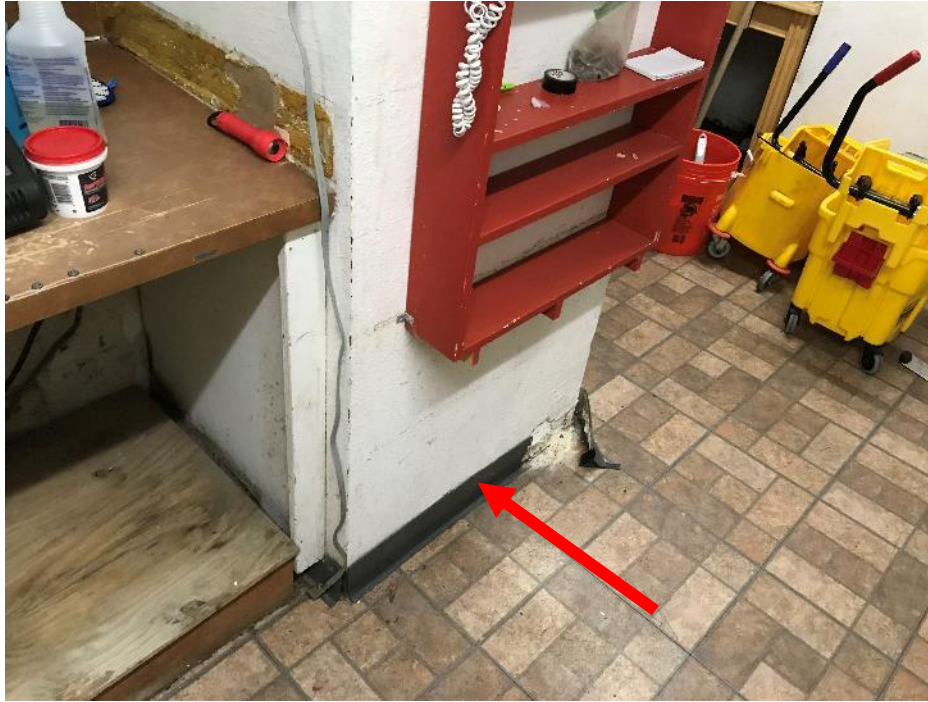
HA No. 17. 4" grey rubber cove base and beige mastic (M)

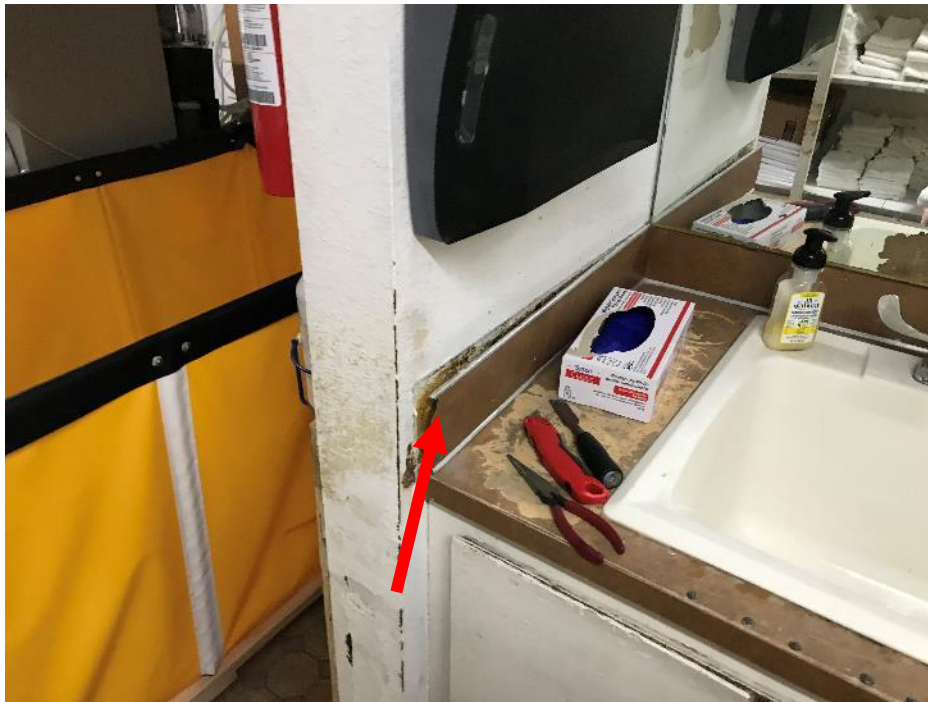
HA No. 18. Brown fiberglass reinforced panel, tan mastic, and joint compound (M)

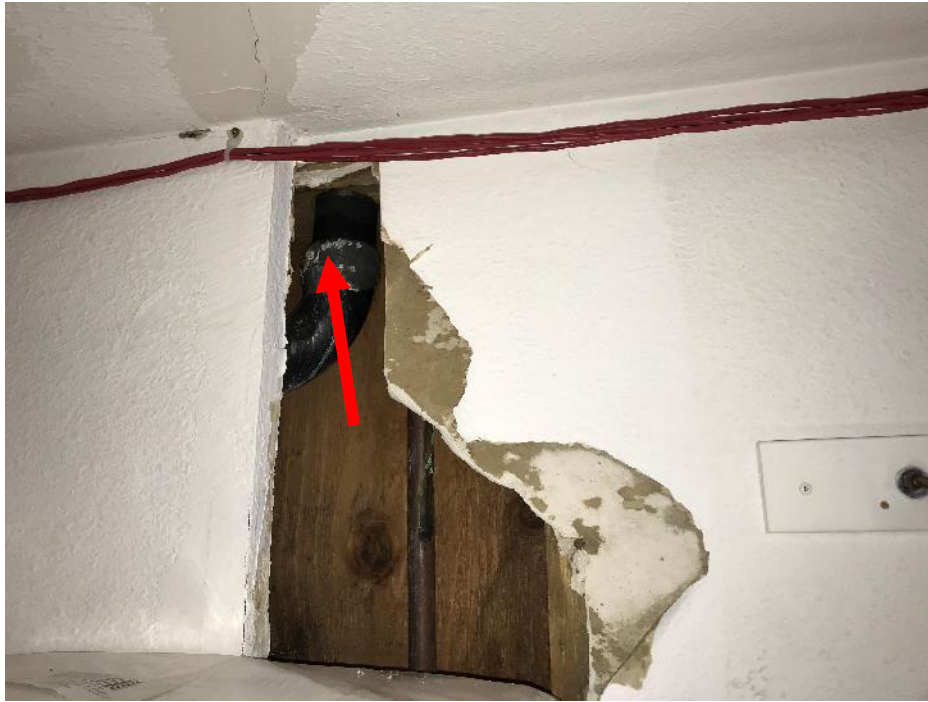
HA No. 19. Grey joint sealant (M)

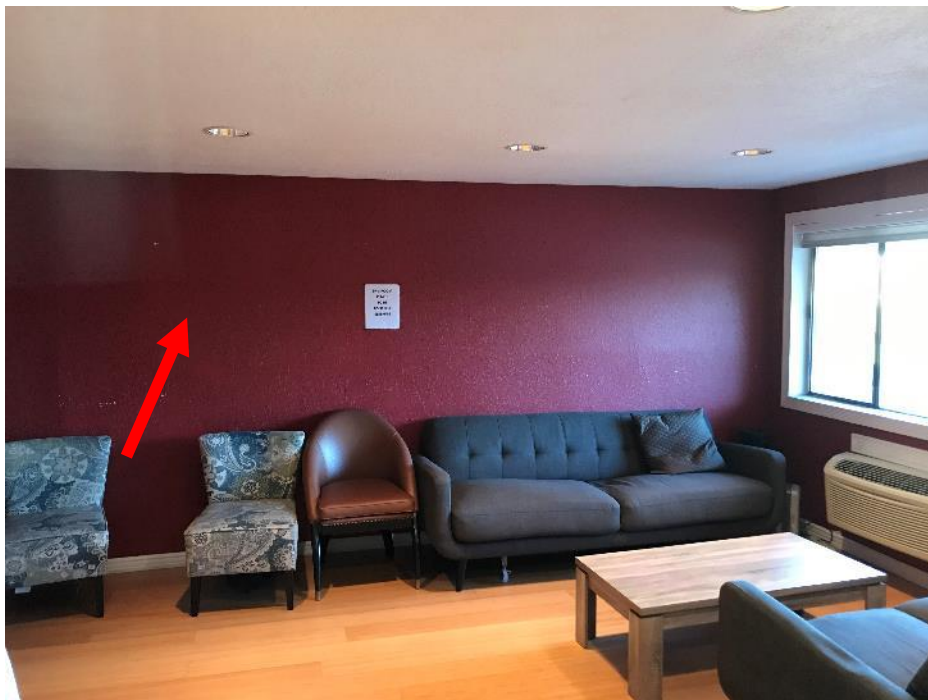
19: Grey joint sealant (M)	Sealant on exposed piping in building B laundry room	ND
20: White texture with mastic, white texture (S), beige wallpaper, and white joint compound (M)	Walls and ceilings in rooms A-01, A-02, A-03, A-05, A-06, A-07, A-201, and B-17	Texture with mastic: ND Texture: ND Wallpaper: ND Joint compound: ND to 3% chrysotile

HA No. 20. White texture with mastic, white texture (S), beige wallpaper, and white joint compound (M)

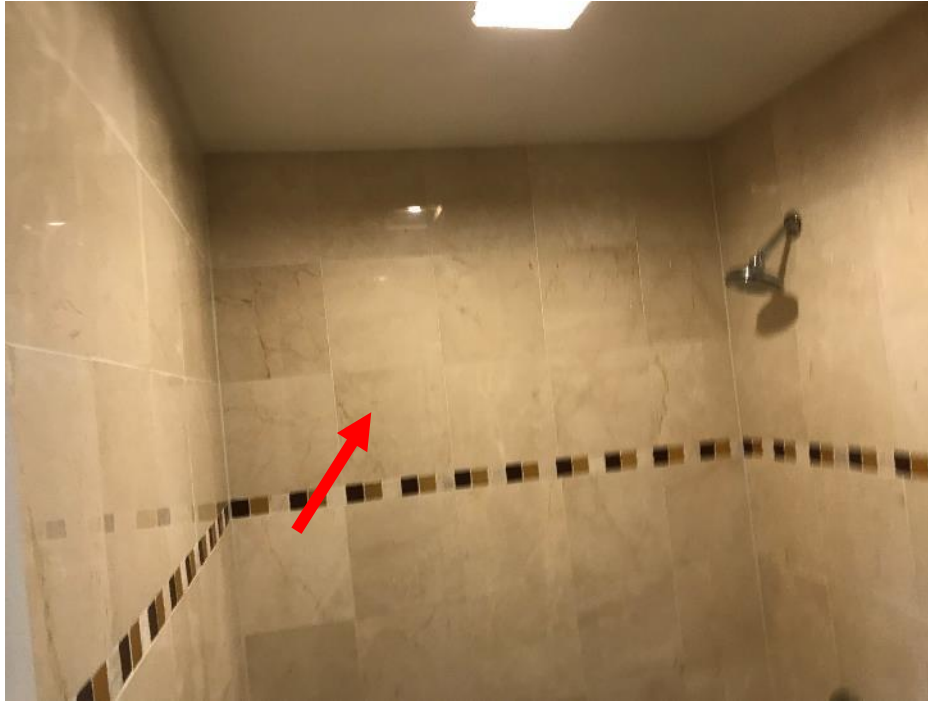
HA No. 21. 12"x 12" white stone tile and white grout (M)

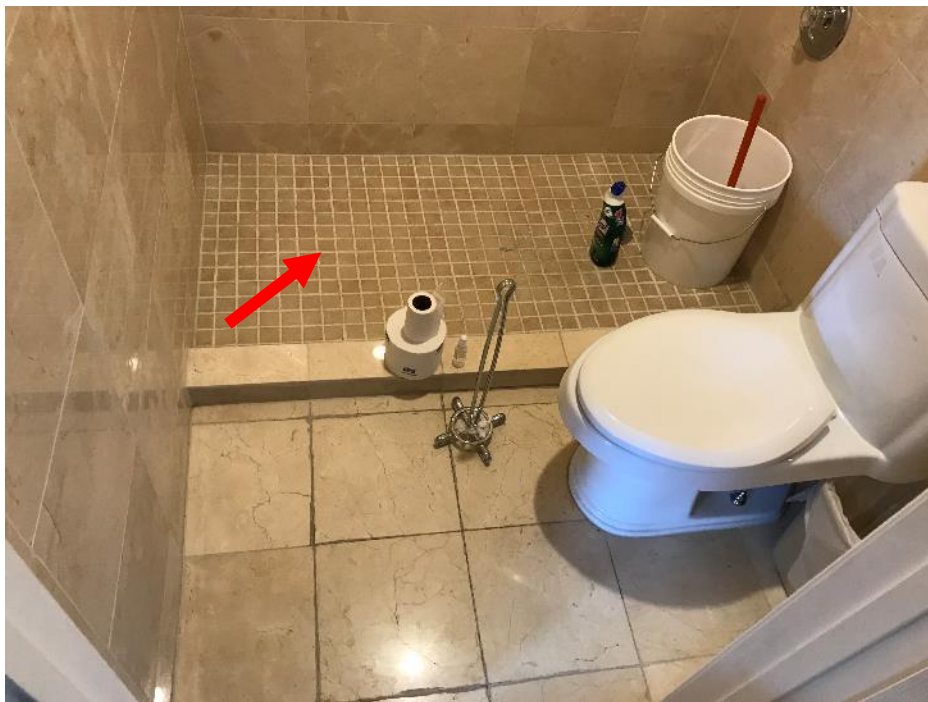
HA No. 22. 2'x 2' white and red ceramic tile, white mastic, and white grout (M)

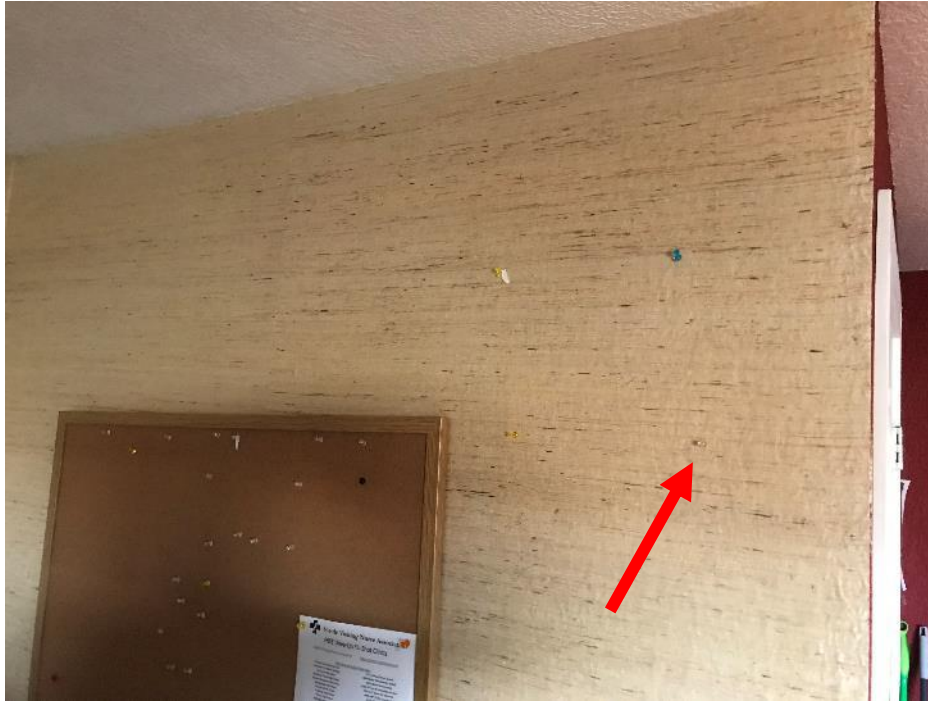
HA No. 23. Beige wallpaper, yellow mastic, and white joint compound (M)

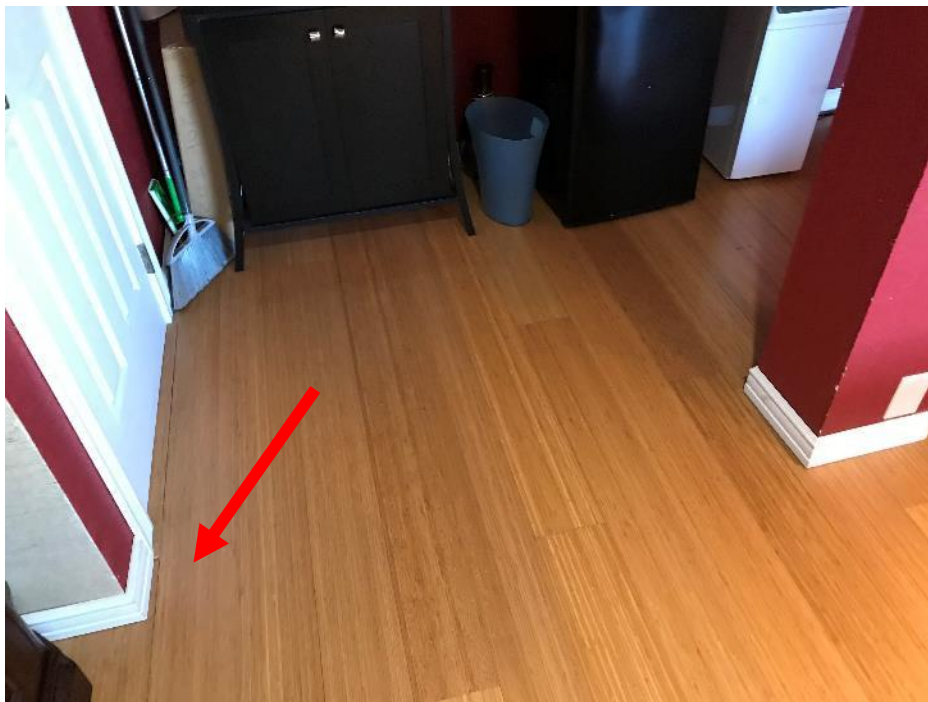
HA No. 24. Black squeak sheet (M)

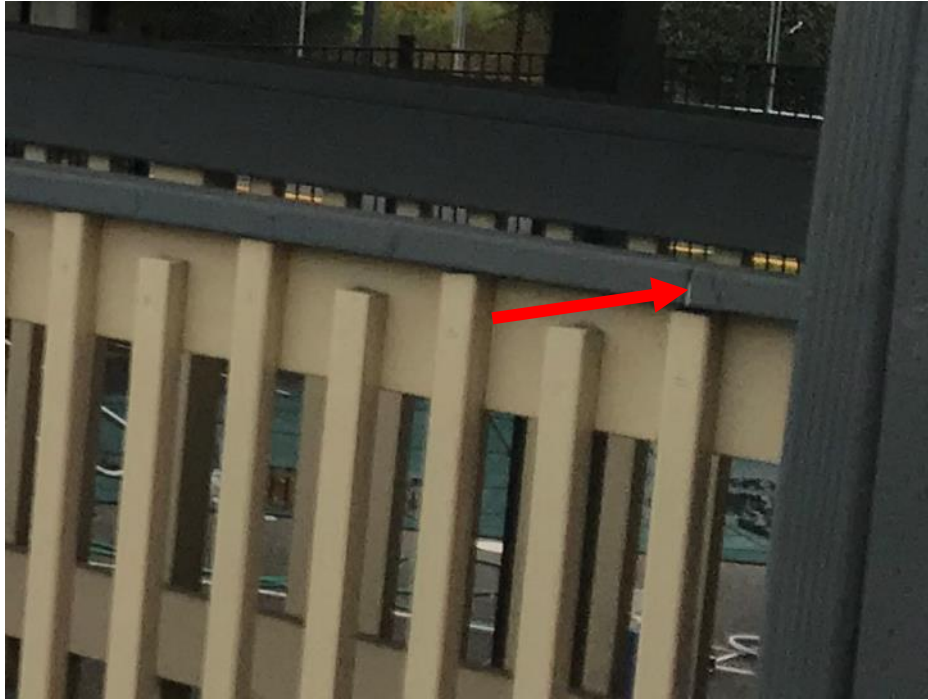
HA No. 25. White putty (M)

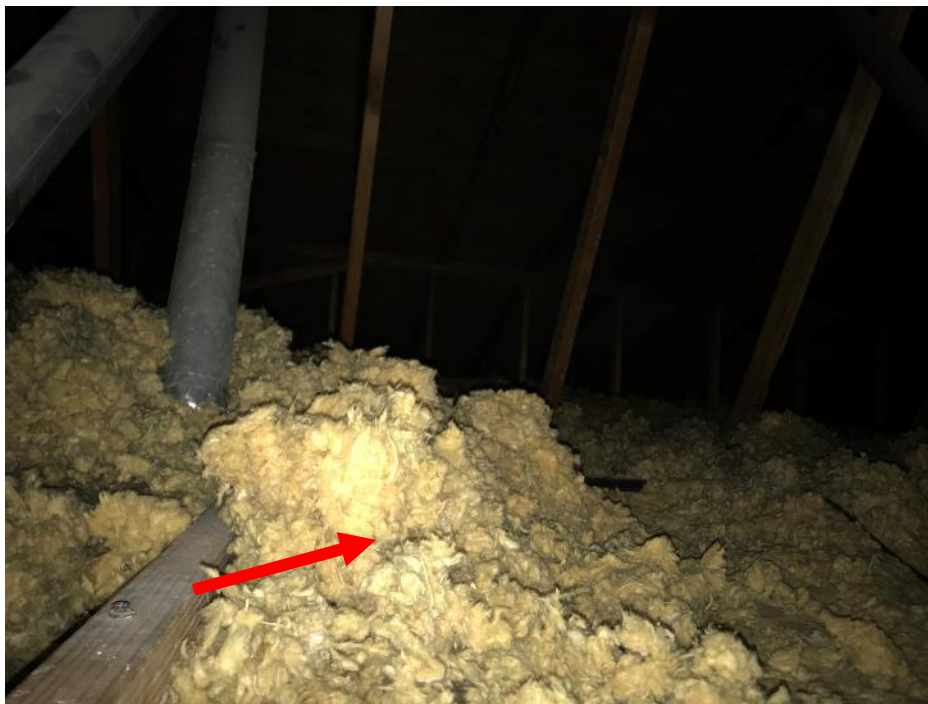
HA No. 26. Yellow fiberglass blown in insulation (T)

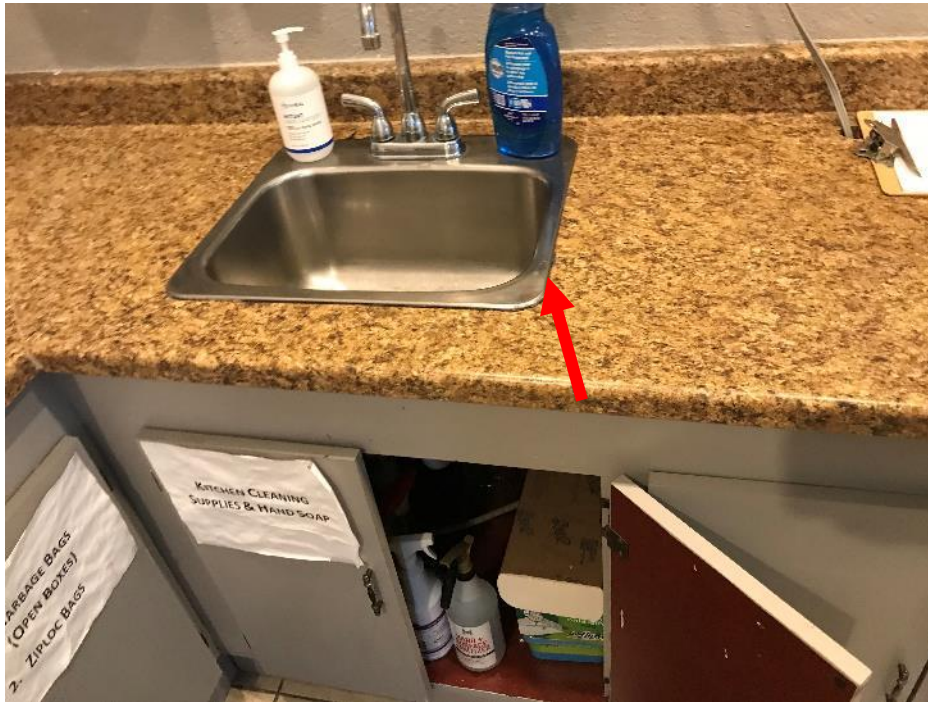
HA No. 27. Clear silicone sealant (M)

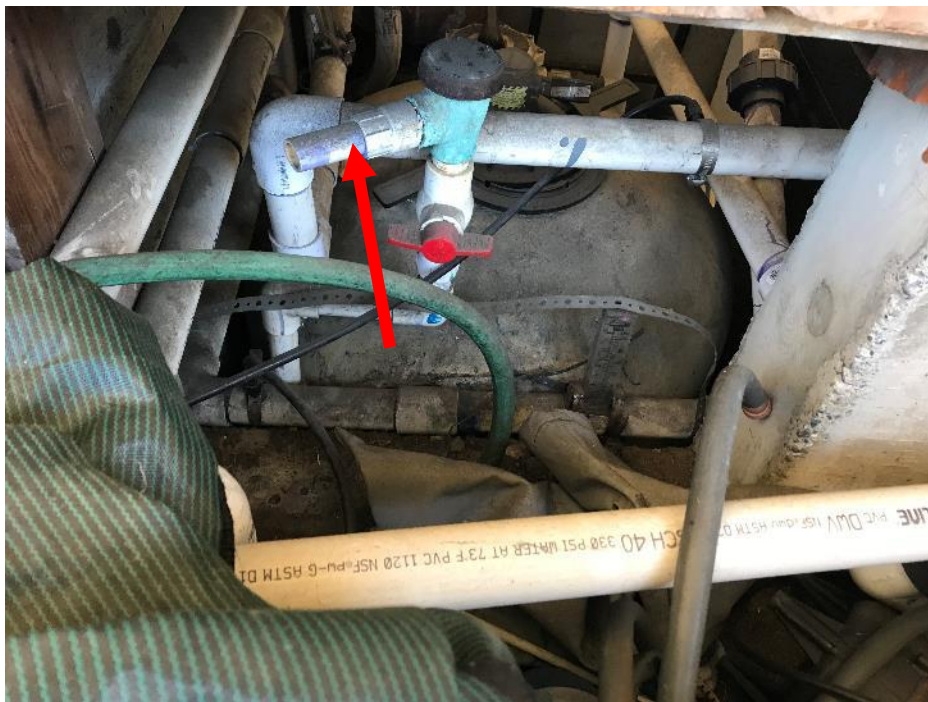
HA No. 28. Black and purple sealant (M)

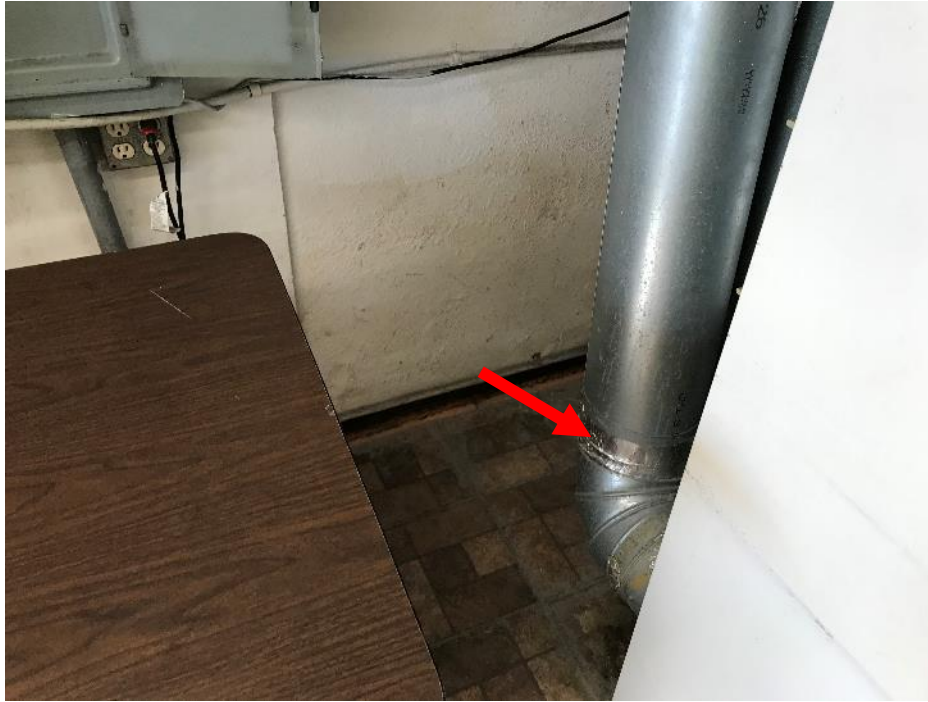
HA No. 29. Silver foil with yellow mastic (M)

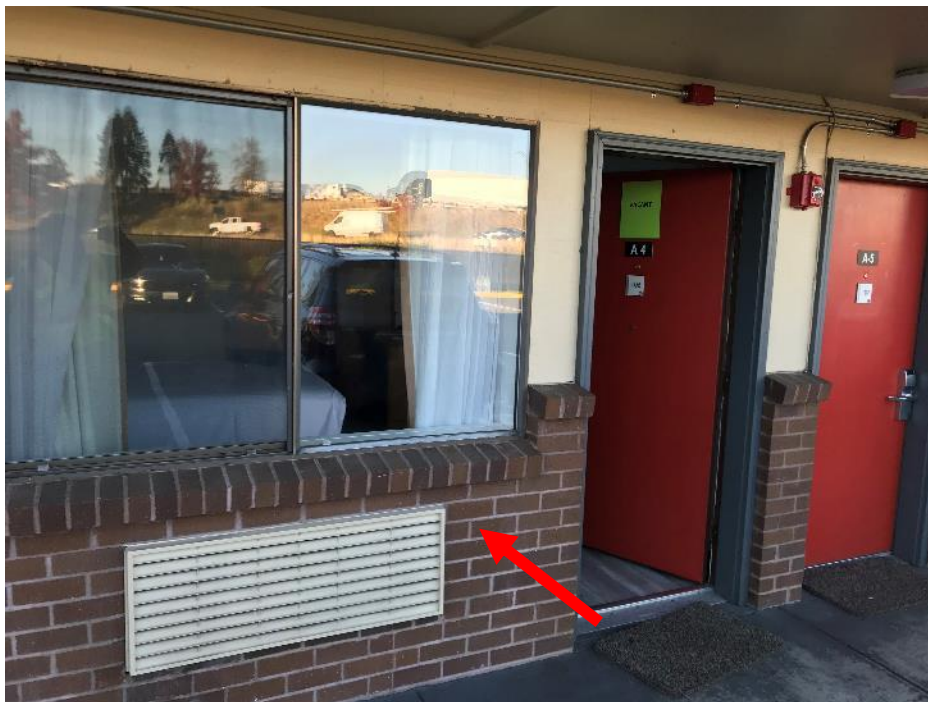
HA No. 30. Red brick and grey mortar (M)

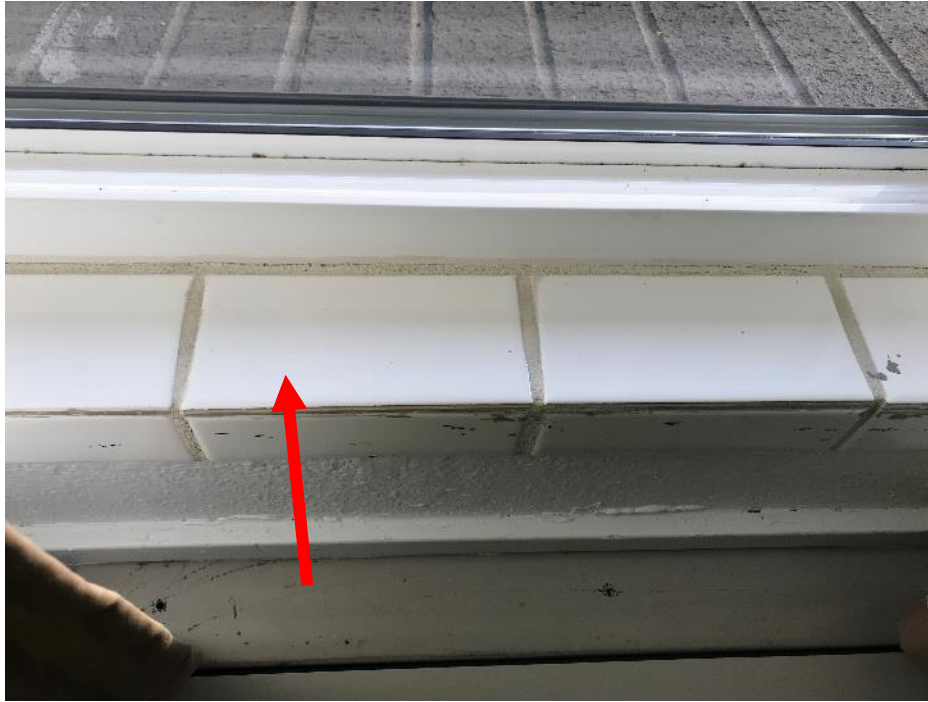
HA No. 31. 3"x 6" white ceramic tile, white grout and white material (M)

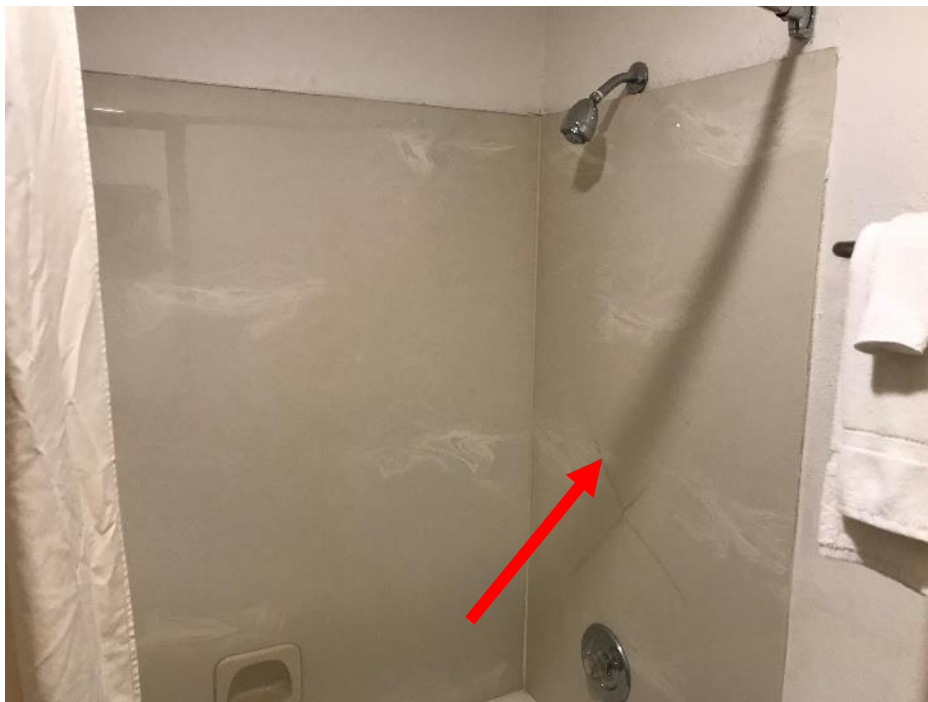
HA No. 32. Marble panel with tan grout (M)

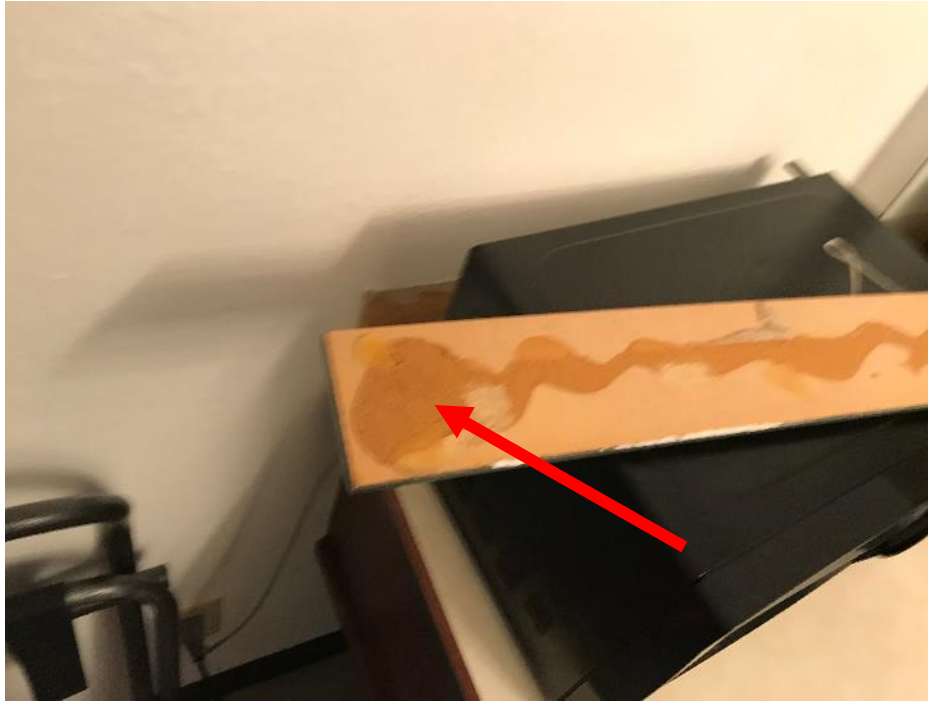
HA No. 33. Yellow mastic and tan mastic (M)

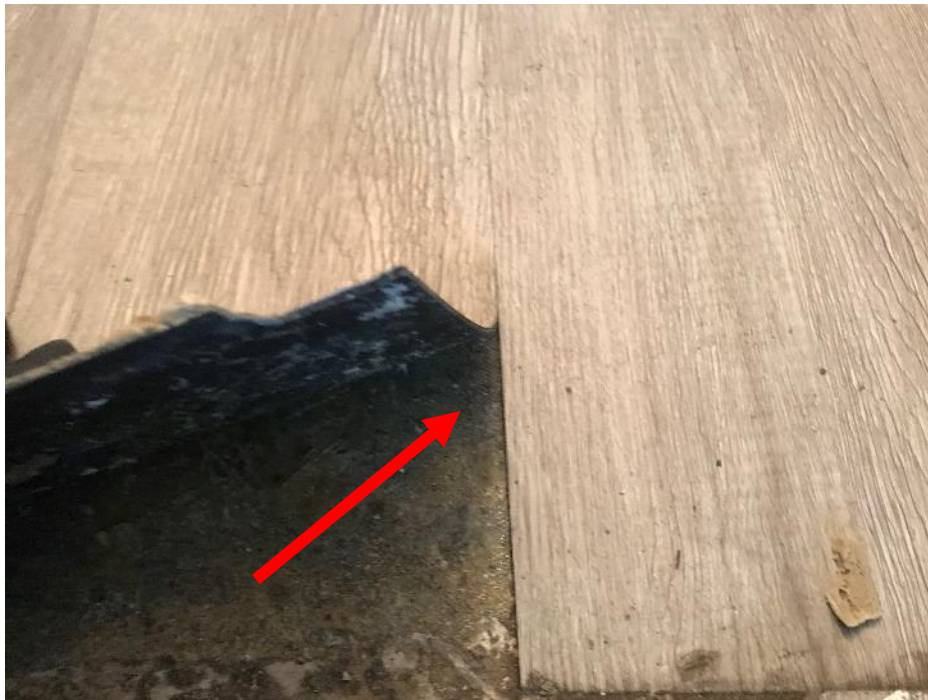
HA No. 34. Grey wood pattern vinyl floor tile, clear mastic, and grey mastic (M)
