Regulated Building Materials Assessment Report

Kent Central Motel
1233 Central Ave North
Kent, Washington

December 3, 2020

Terracon Project No.81207486

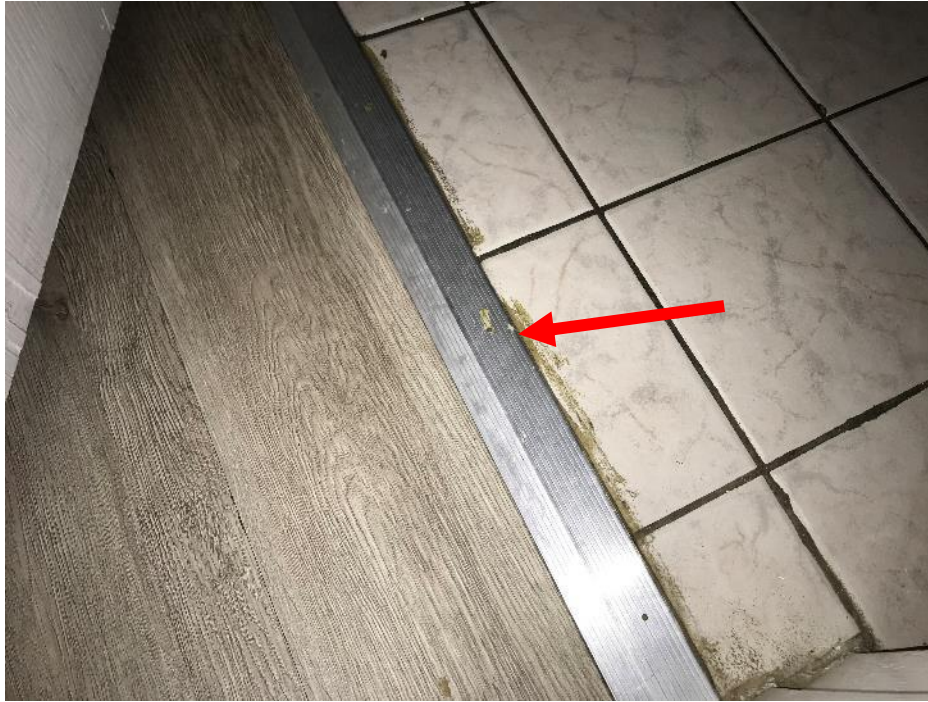
HA No. 35. Tan mastic and grey material (M)

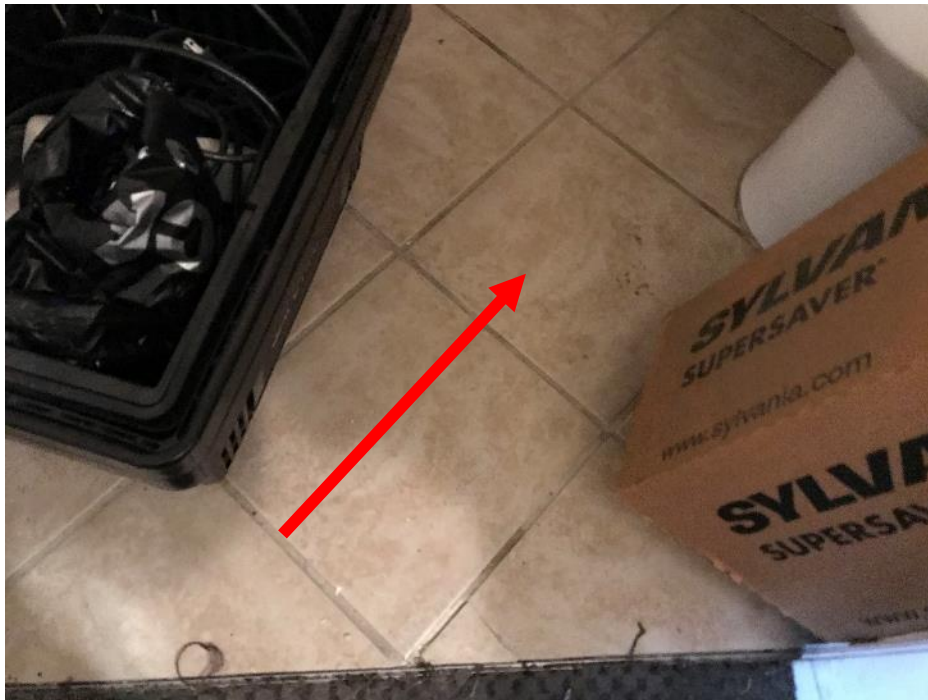
HA No. 36. 12"x 12" tan ceramic floor tile, beige grout, and white mortar (M)

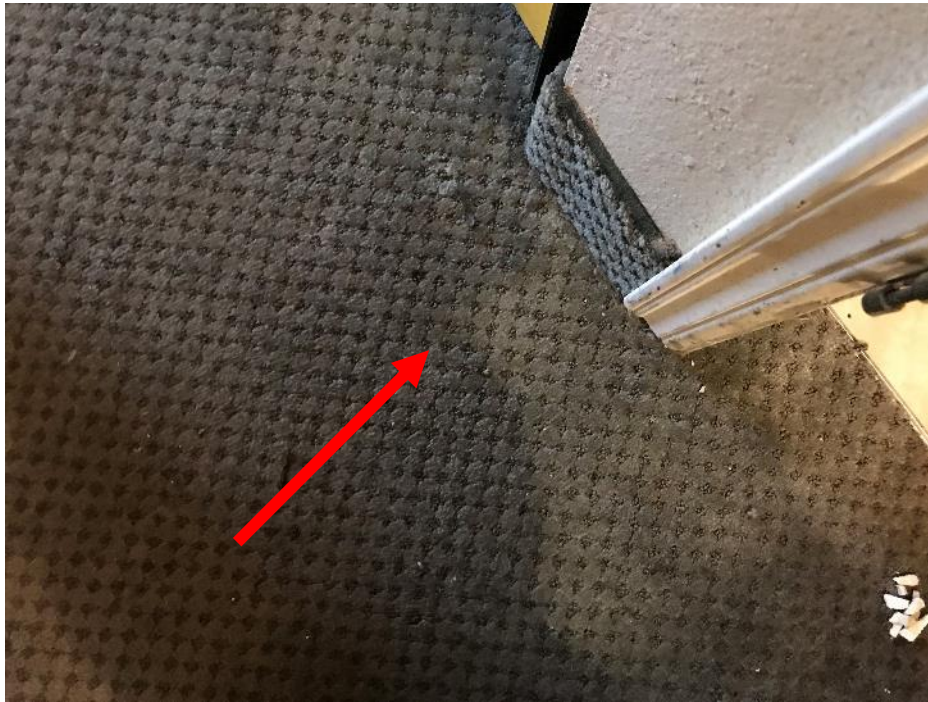
HA No. 37. Grey carpet (M)

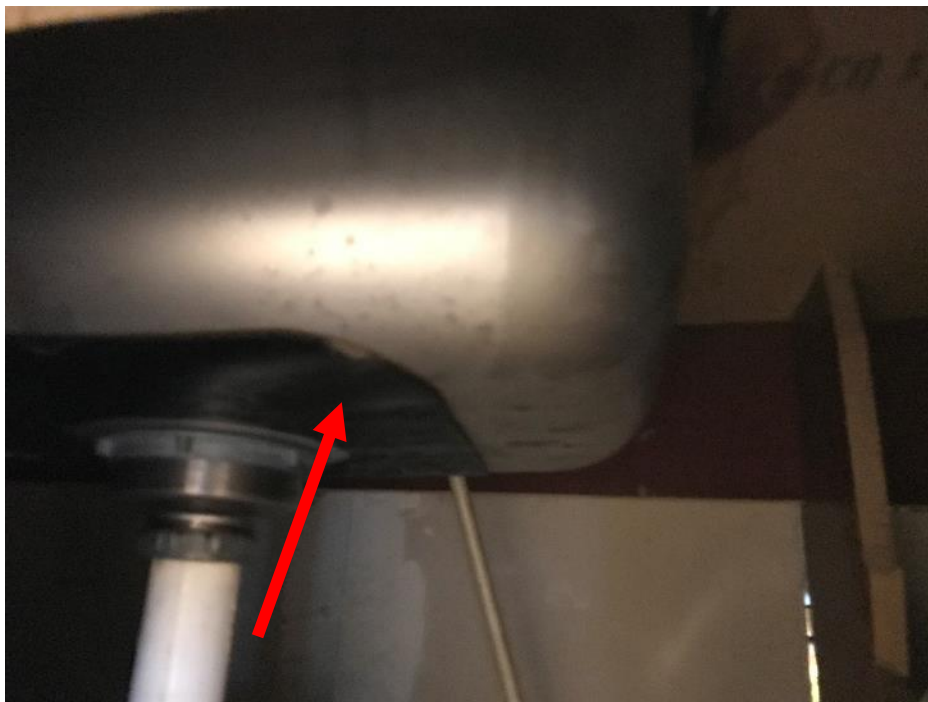
HA No. 38. Black sink undercoating (M)

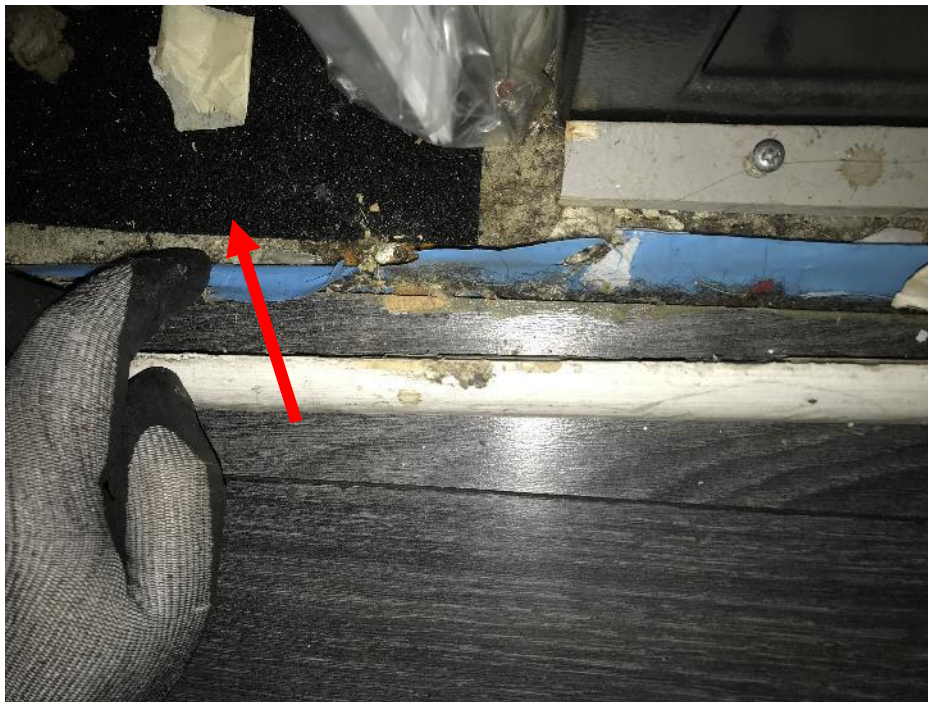
HA No. 40. Beige mastic and black foam pad (M)

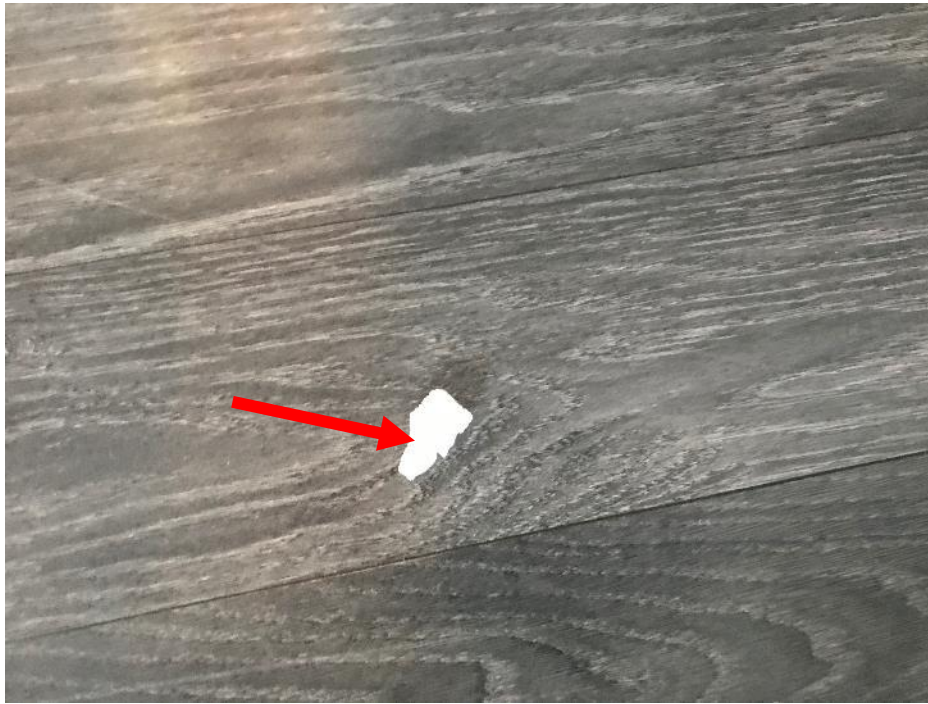
HA No. 41. White foam (M)

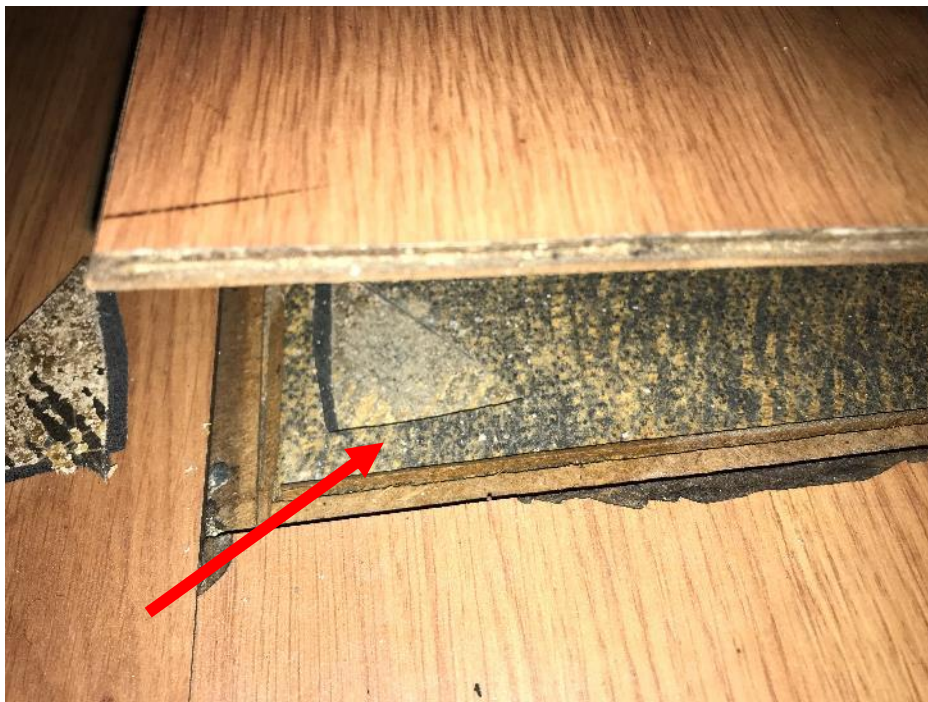
HA No. 42. Black foam with tan mastic (M)

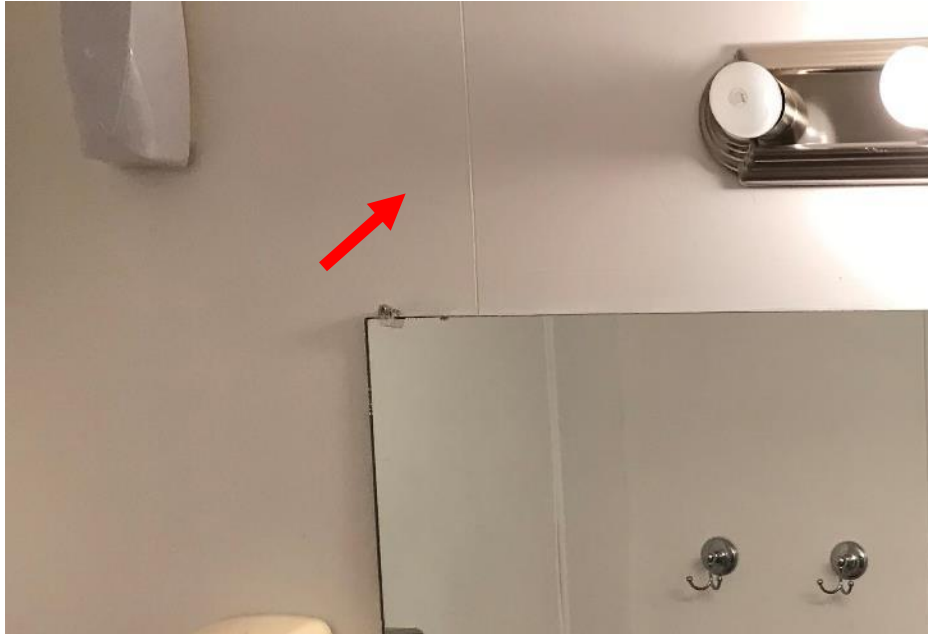
HA No. 43. Tan sealant (M)

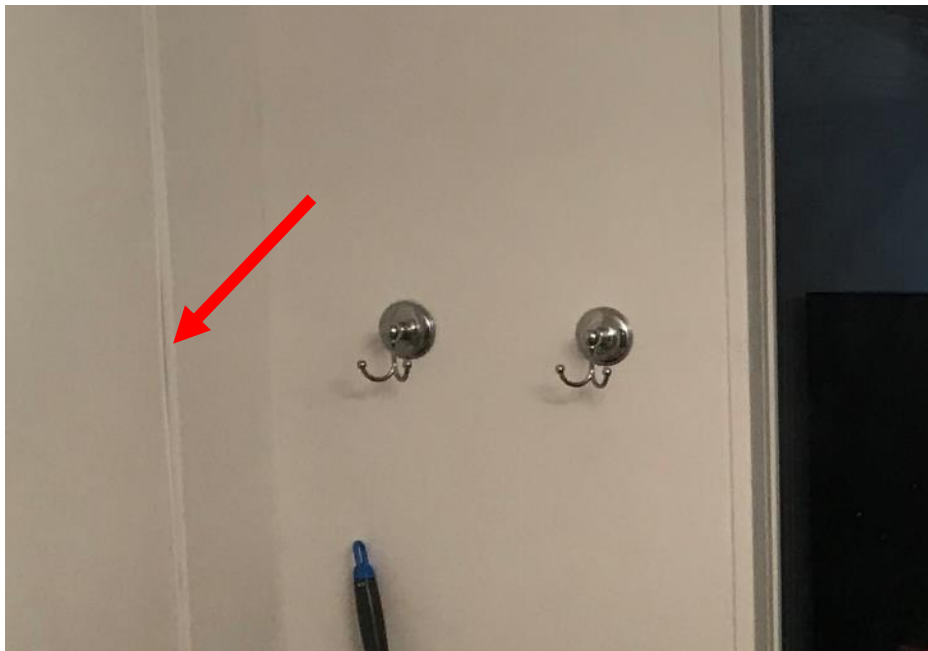
HA No. 44. Tan fiberglass reinforced panel with mastic (M)

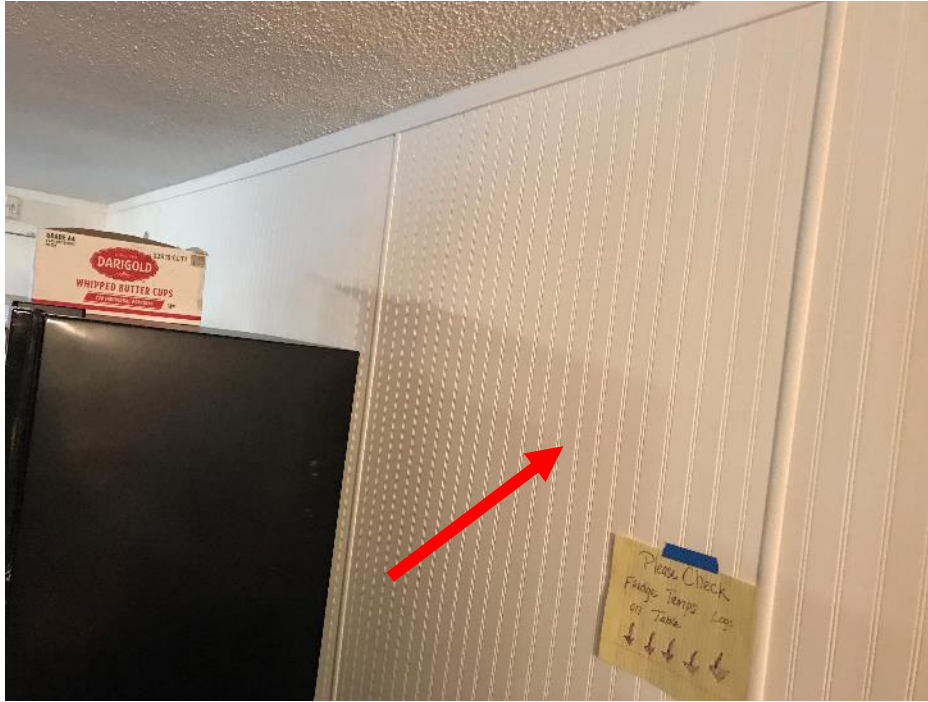
HA No. 45. Wall panel mastic (M)

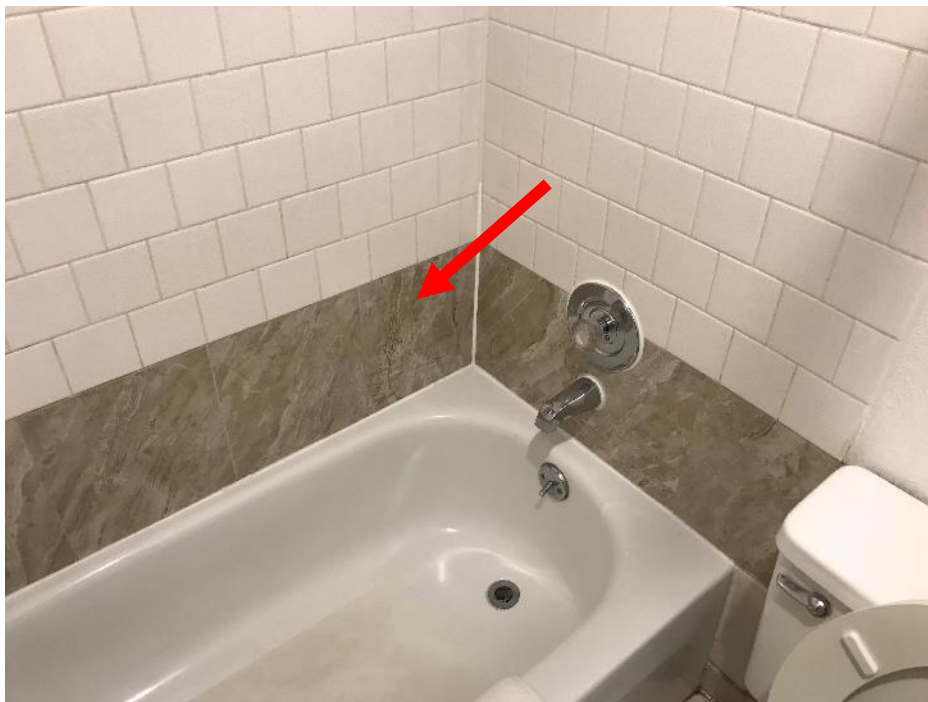
HA No. 46. 12"x18" grey marble pattern ceramic tile with grout (M)

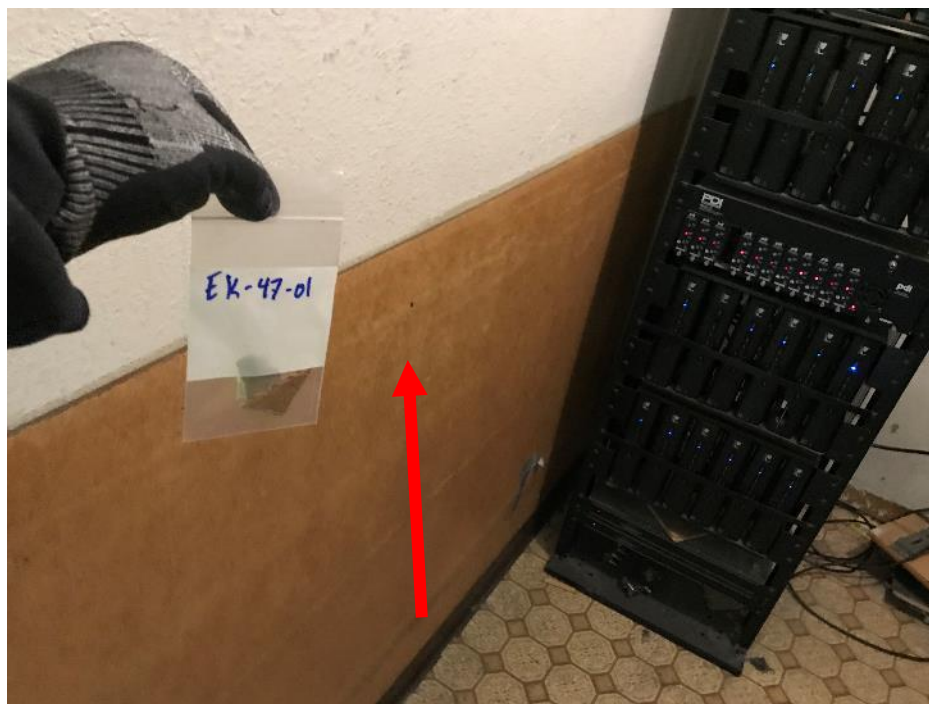
HA No. 47. Brown compressed fiber board and brown mastic (M)
